# **KINGS DOCK CAR PARK FIRE**

## **PROTECTION REPORT**

*April 2018*

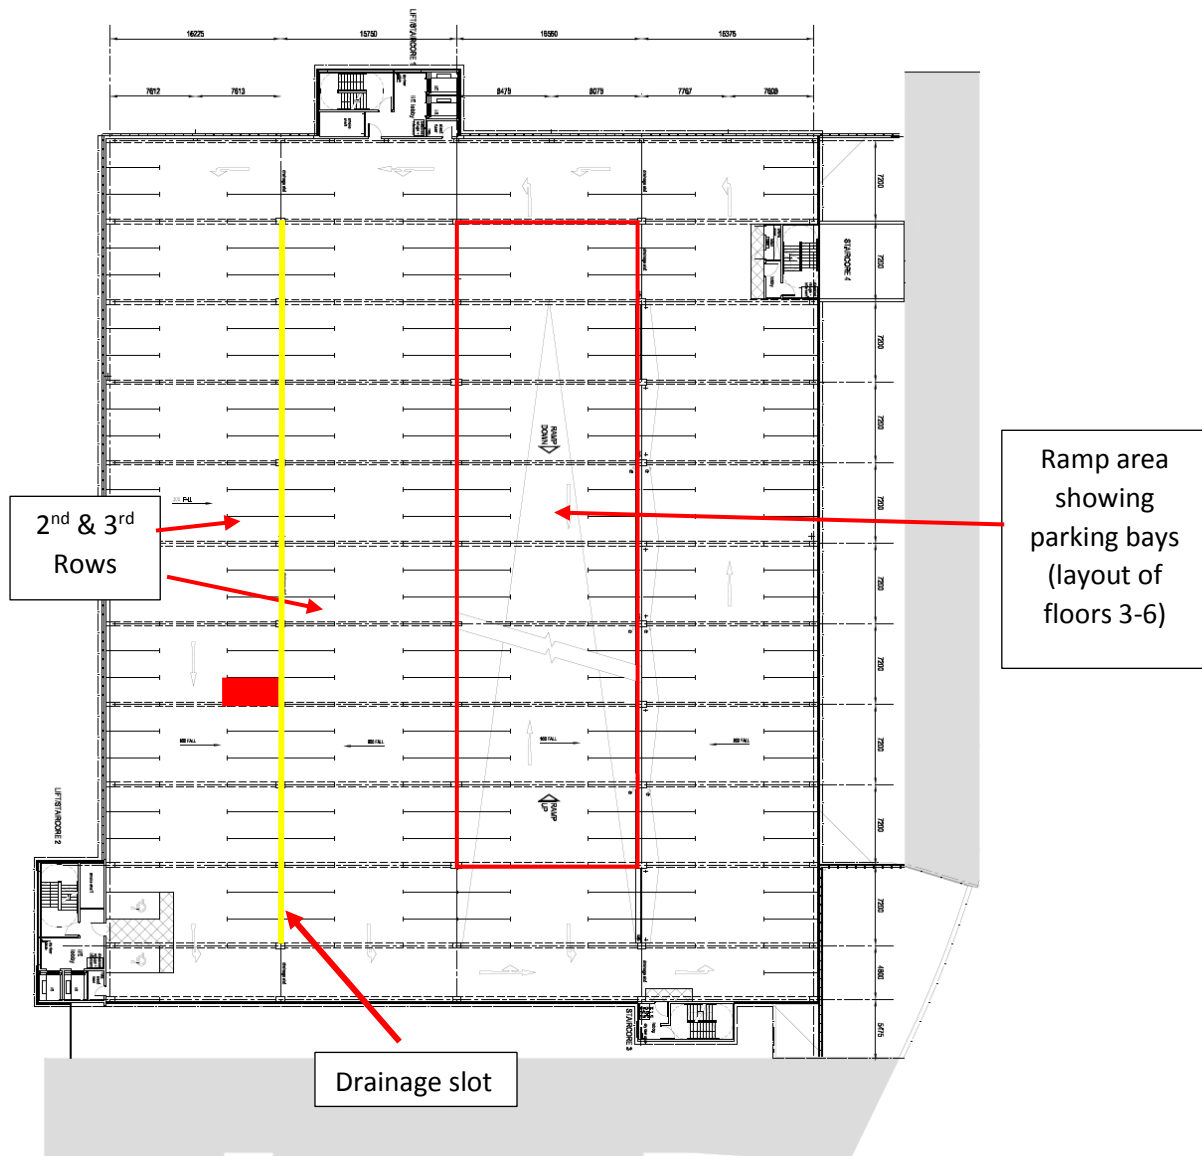
Figure 2.1.1: Level 3-6 floor plan with drainage and ramp system

From initial observations, CCTV and open Social Media sources it could be seen that the fire, once sufficiently developed, moved rapidly up through the structure. Early thoughts around this concentrated on vehicles being parked on the ramps between floors as a possible factor in fire spread.

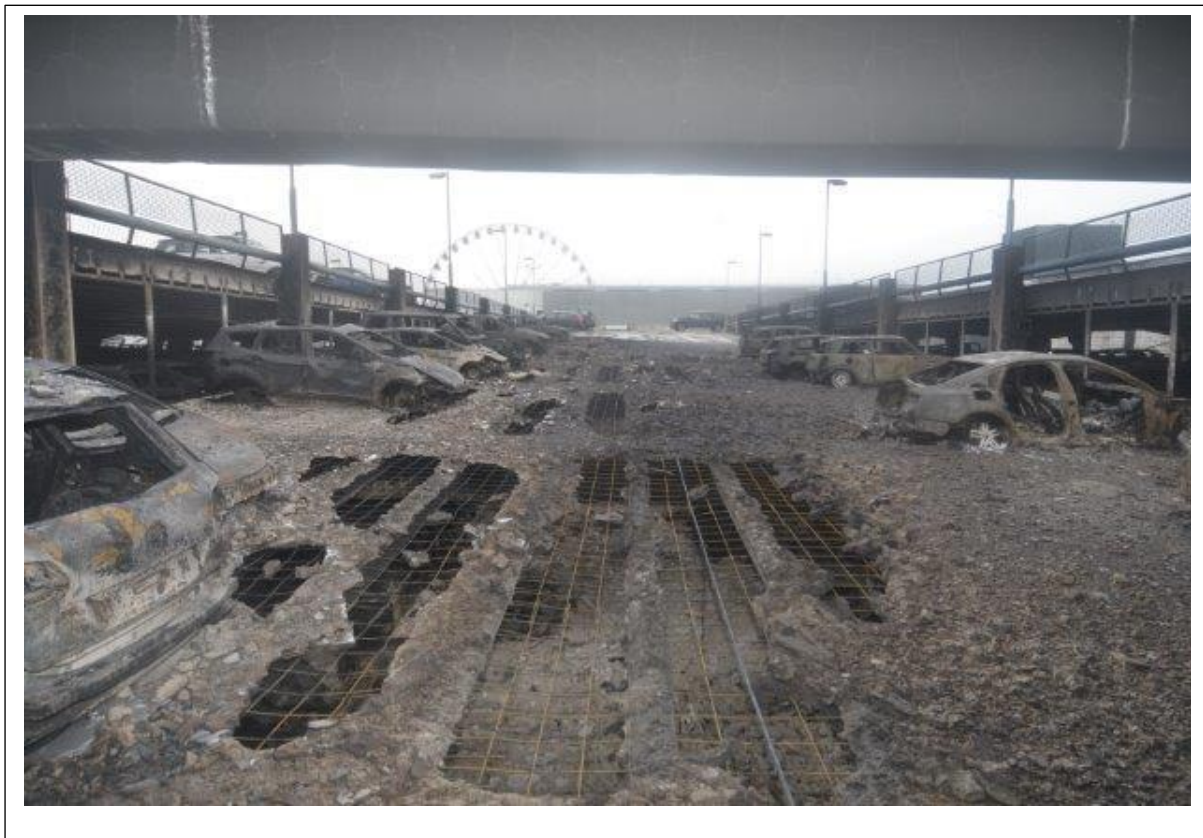
**Figure 2.1.2: Photograph of ramp from level 6 to level 7**

BA teams and external firefighting personnel had reported spalling or exploding concrete, with BA teams seeing debris falling down from the ceilings on level 3. The later BA teams also reported holes in the ceiling on level 3 and ignited fuel running down like a waterfall from the floor above.

The explosive spalling of the concrete, particularly of the precast ribbed floor slab, may have provided an additional route for fire development between levels. However, the fire severity for this event to occur would be well in excess of the fire design resistance period. The integrity of the concrete and its resistance to spalling will depend on many factors, such as water content; whether the concrete is reinforced and the aggregate and materials used.

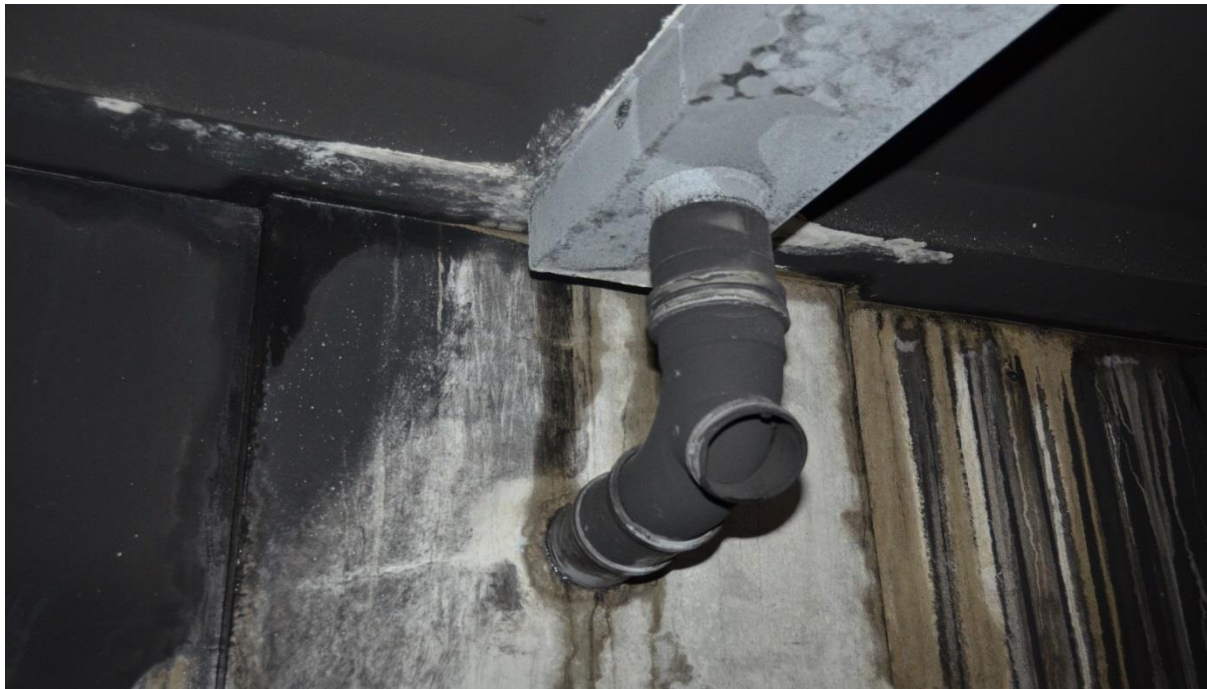
Figure 2.2.1: Photograph of intact drainage system type adjacent to vehicle of origin

This is considered as the likely cause of initial fire spread between level 3 and 4.

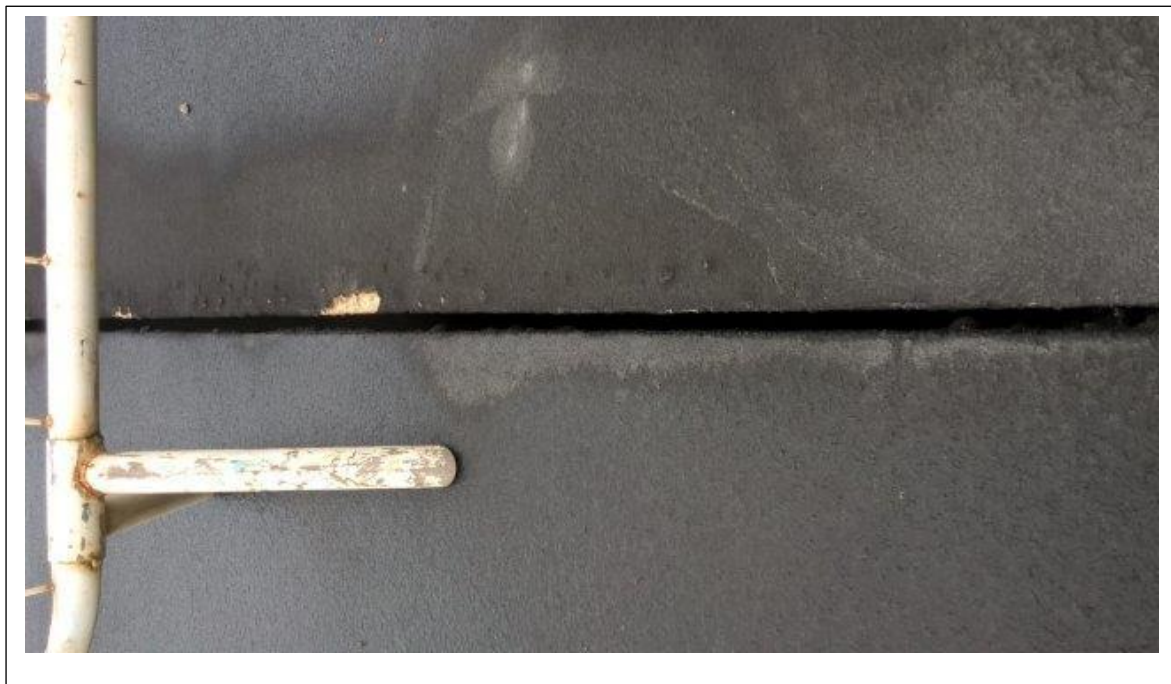
Figure 2.2.2: photo view of the drainage slot from above, Level 7 Roof

This drainage slot runs between columns with two rows of three cars parked between each column (see fig.2.1).

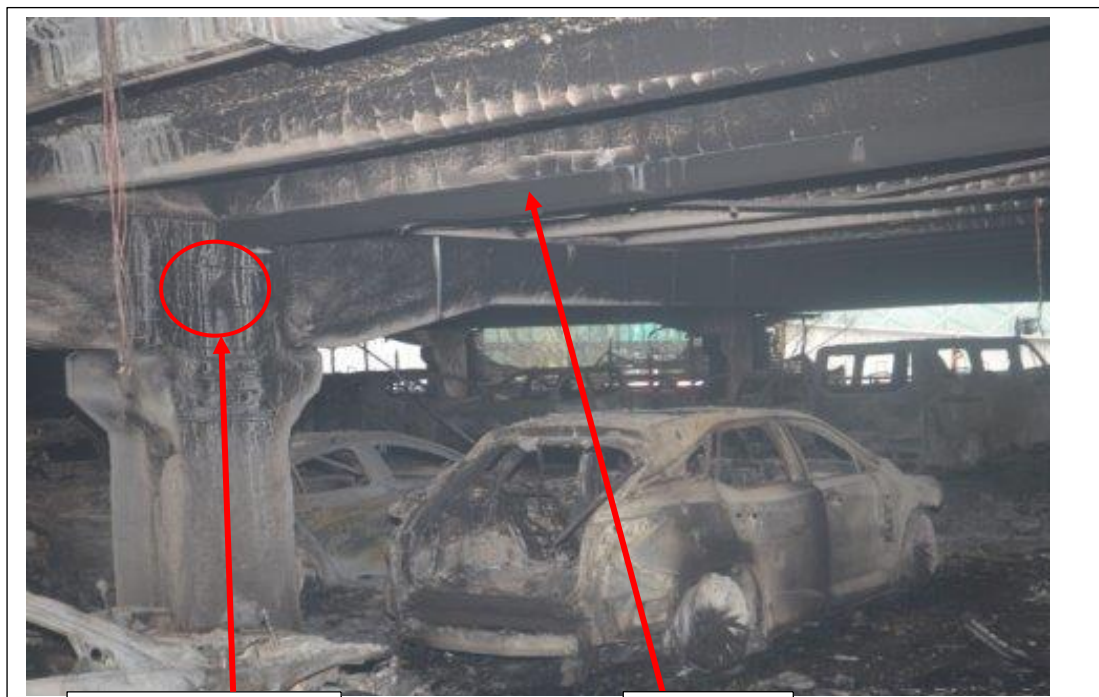
Figure 2.2.4: section of aluminium guttering in place.

Plastic drainpipe elbow burnt away.

Aluminium guttering

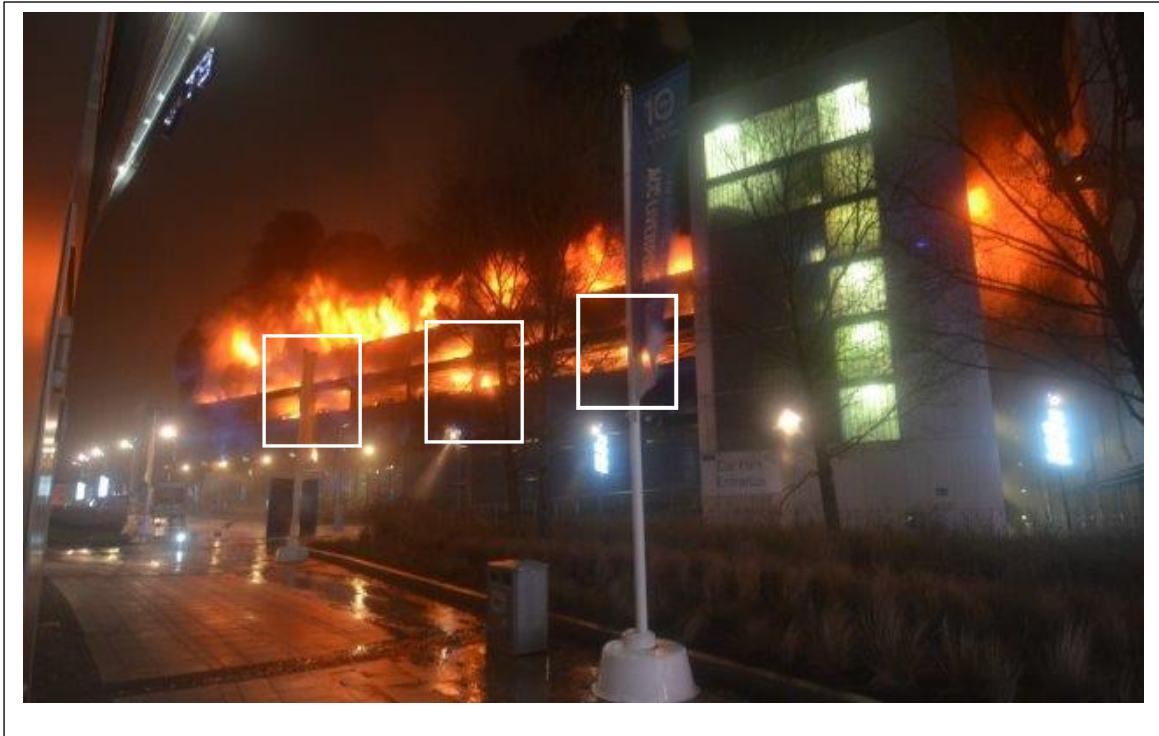
**Figure 2.2.5 External CCTV image**

The external CCTV image below (**fig.2.2.5**) appears to show vertical walls of fire at equidistant positions along the length of the level. This would appear to be further evidence of drainage failure and the “waterfalls of fire” that BA crews alluded to.

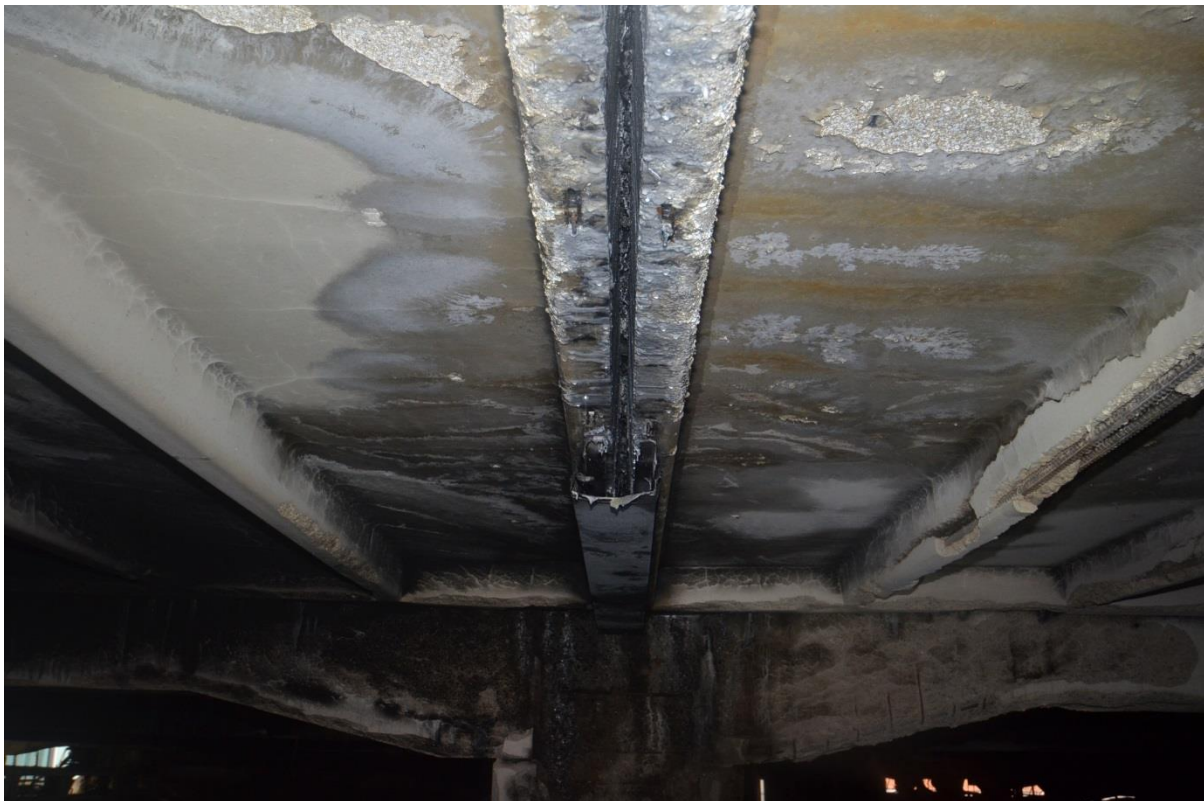
**Figure 2.2.6: melted aluminium drainage tray and visible drainage slot**

With temperatures in excess of 1,200°C, very early failure of plastic elbow pipes would have occurred and with a melting point of 660°C, the aluminium drainage trays would also have been subject to failure (**see fig.2.2.6**) prior to the spalling of the concrete ribbed floor slabs. Failure of the aluminium tray would expose the drainage channel and allow hot gases and flame to be directed to the floor above and impinge on the two rows of cars adjoining this channel.

A section of undamaged drainage tray from the car park has undergone testing by BRE. This has confirmed it to be 2mm thick aluminium, which would fail at around 660°C.

1. Fire may spread beyond floor of origin. In the case of Kings Dock evidence would suggest that this was initially through the failure of the drainage system and was later exacerbated by the failure of the ribbed slab floor. Although the geometry and central ramp design, combined with running fuel fires, certainly contributed at a later stage in the incident. Designers should give serious consideration to the implications of drainage design that could aid fire spread between levels.

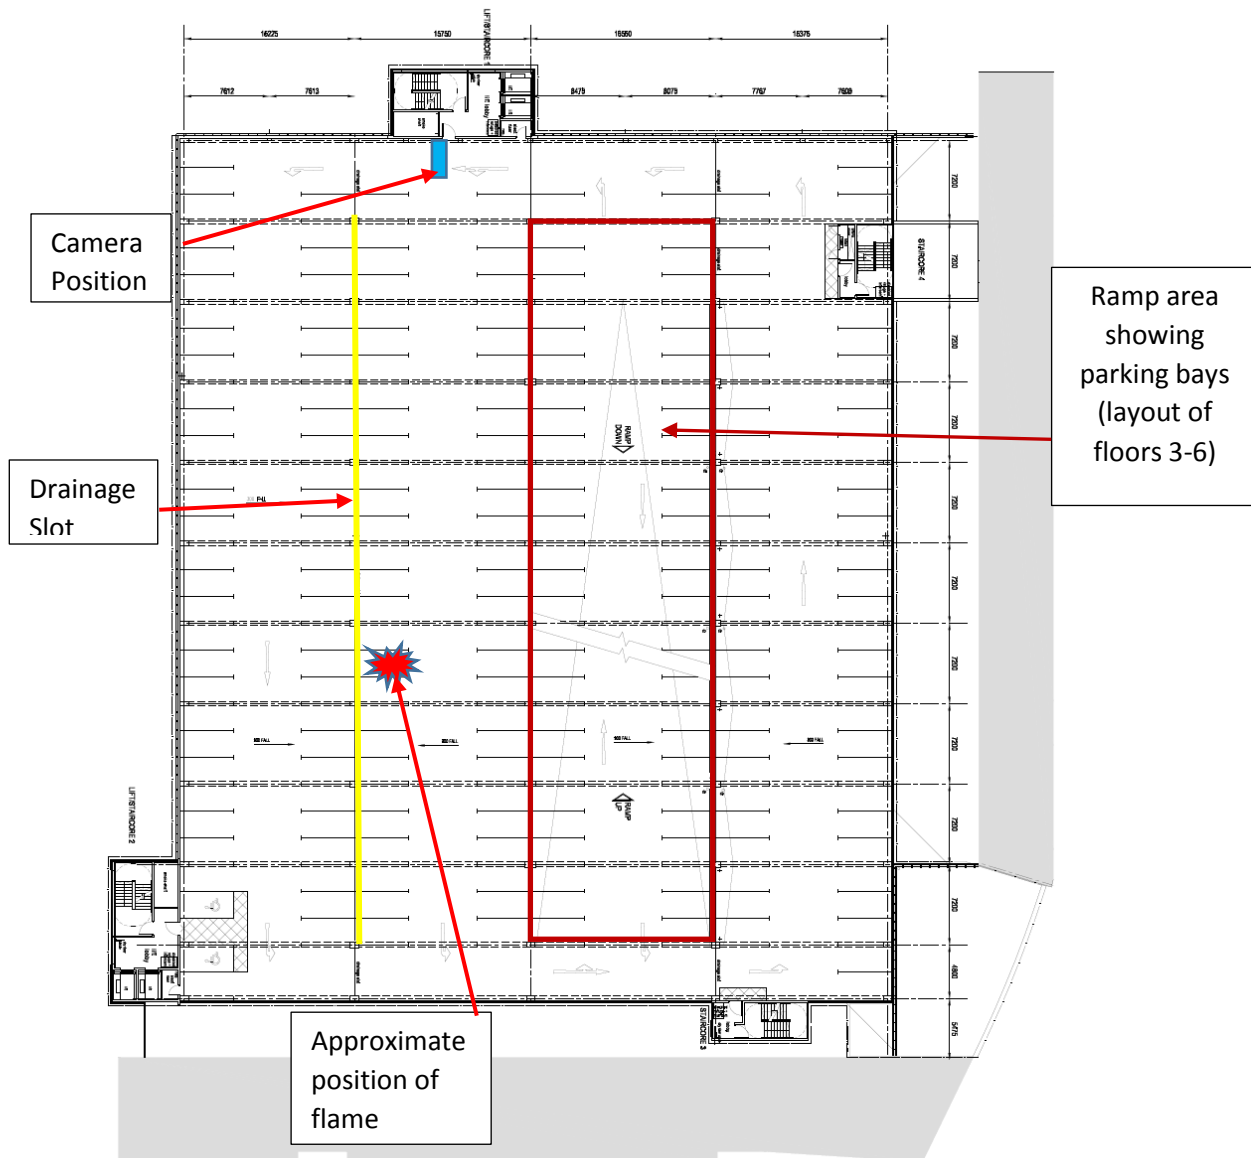
**Figure 2.3.1: Level 4 floor plan and position of fire break through**

The following plan and images show the first signs of flame captured by CCTV camera outside stairwell 1, level 4 at 17:53hrs (**figure 2.3.2**) and then a well-developed fire at 18:11hrs (**figure 2.3.3**), with several vehicles involved. A major fire event occurred on level 4 shortly afterwards and fire crews were withdrawn for firefighter safety.

This evidence is further proof that the fire spread occurred through the floor, via the drainage system, as the flame is practically directly above where the original fire started. None of the cars adjacent to the ramp are involved in fire at this point. The images showing fire development on level 4 also mirror, to a great extent, the BRE experiments conducted between 2006 and 2009, where multiple vehicles become totally involved in fire in a short period of time, approximately 20 minutes after first ignition.

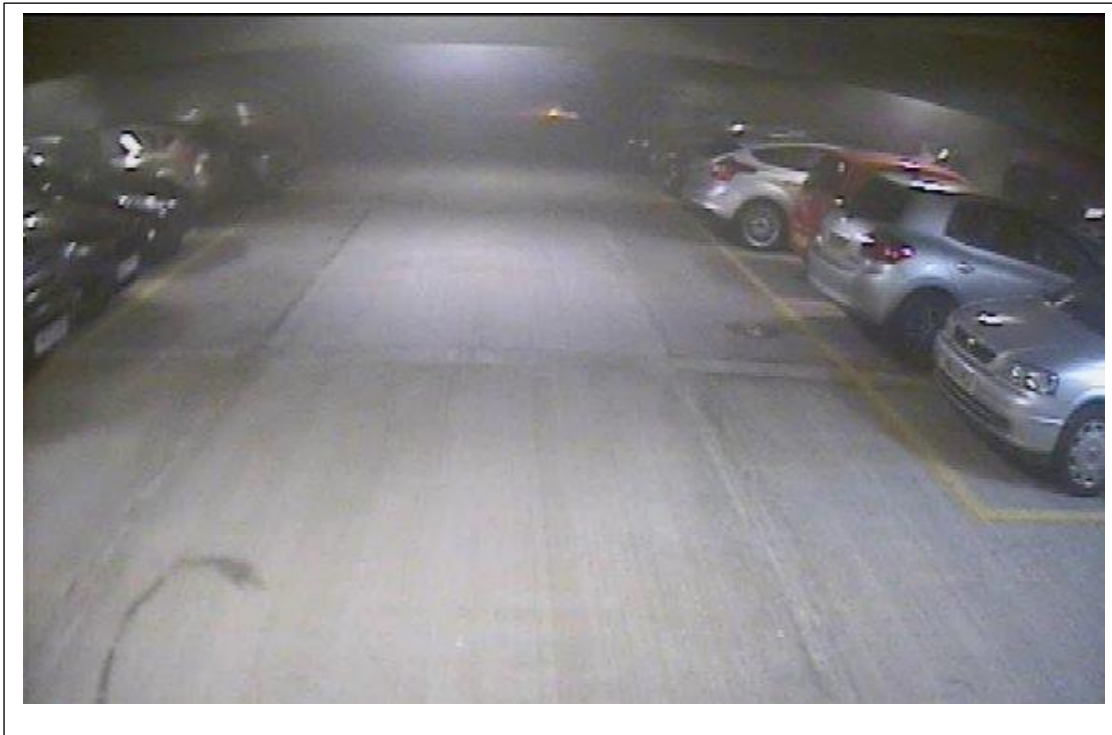
**Figure 2.3.2: First Sign of Flames on level 4 at 17:53hrs**

**NB flames may have been present on level 4 earlier than 17:53 but they were not captured by CCTV due to smoke obscuration. Firefighters on level 3 had reported “waterfall of fire” at 17:35, when they returned to BA entry control point.**

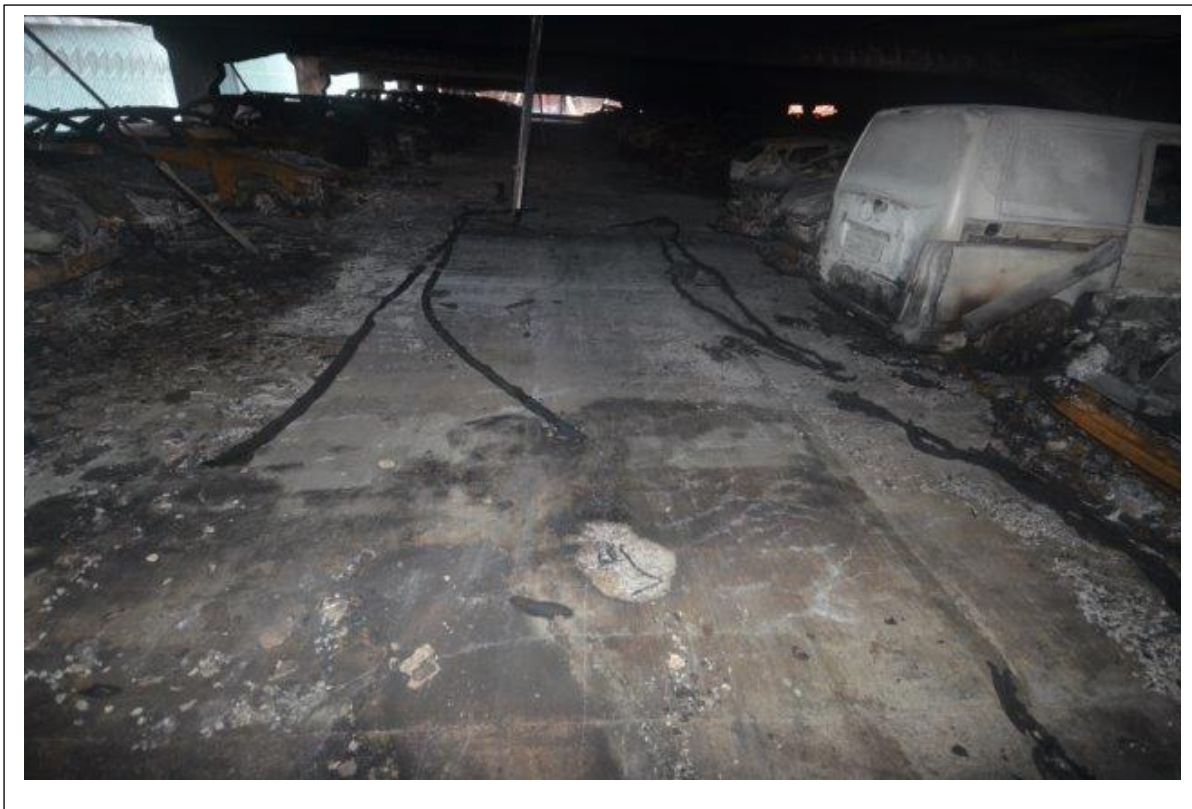
**Figure 2.4.1: Photograph of Spalled Concrete: Level 3**

Areas of the roadways within the car park, sited away from any parked vehicles, appear to have suffered spalling.

The image above appears to show a distinct difference in surface temperature of the concrete on level 3. The different colouring and the spalling of the floor towards the bottom of the photograph, combined with the two lines of burnt delivery hose, having been vaporised beyond the line of colouration change, would appear to support evidence of very high localised temperatures. In the early stages of the incident, wind direction was coming north easterly (coming towards the camera view for this photograph) and firefighters had to withdraw from this area due to the untenable conditions.

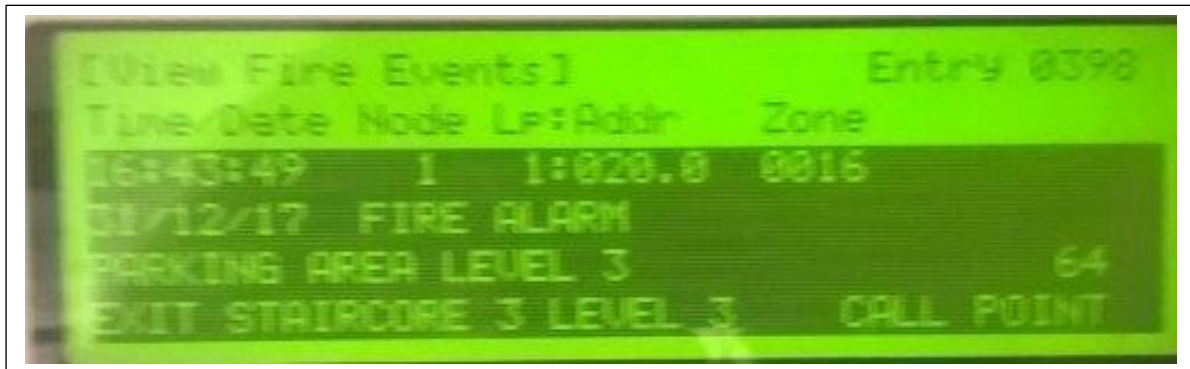
**Figure 3.4.2: Photograph of Alarm Panel, 1st Actuation**

The fire alarm was first actuated at 16:43:49, alarm panel indicating call point 64, level 3, adjacent to escape stairwell 3.

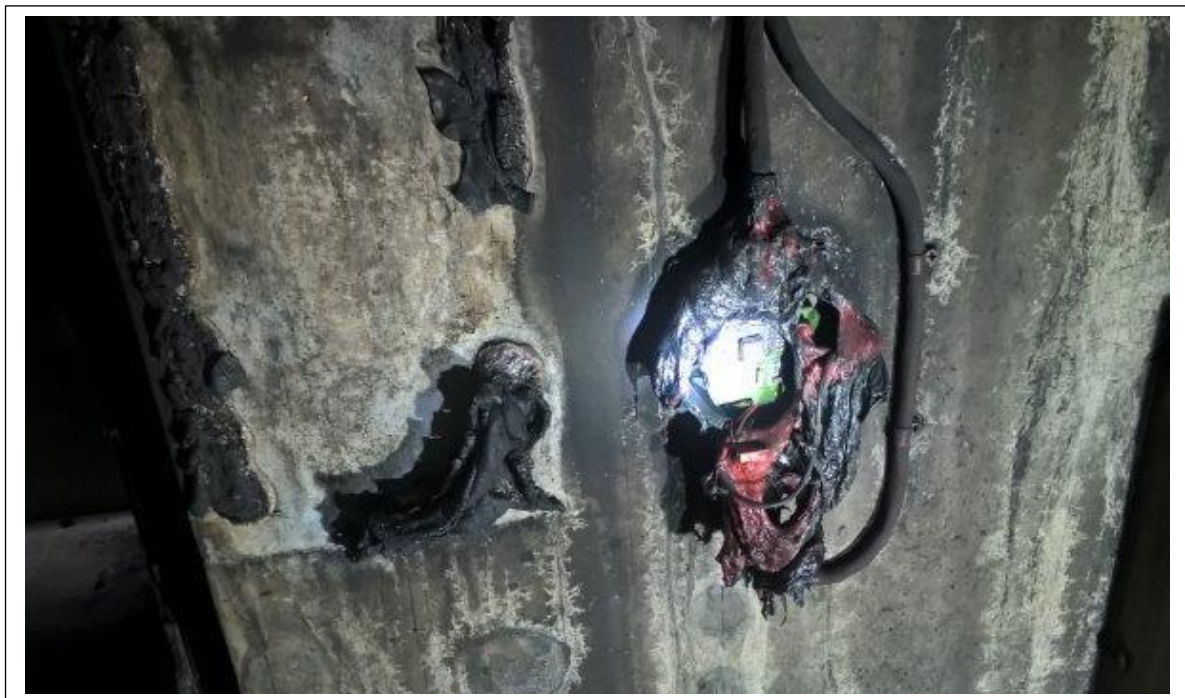
**Figure 3.4.3: Photograph of Damaged Call Point on Level 3, Outside Stairwell 3**

However, it was not possible to visually identify this call point, due to fire damage.

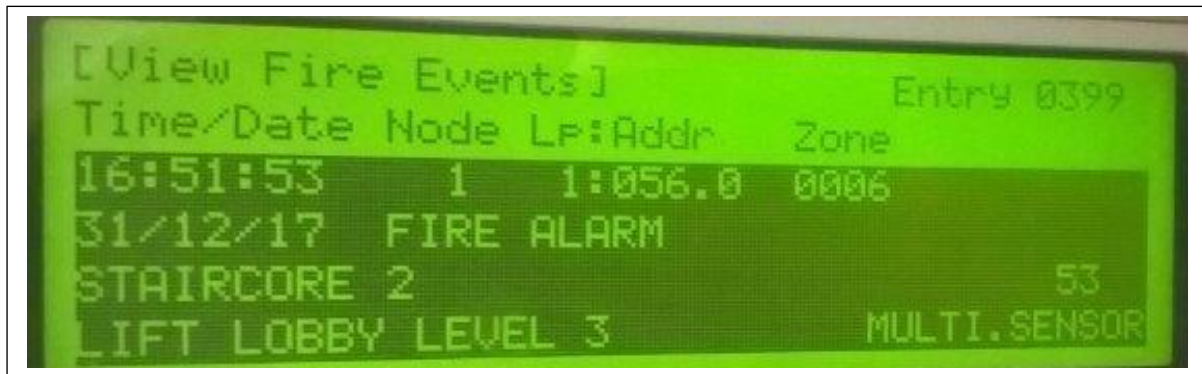
**Figure 3.4.4: Photograph of Alarm Panel, 1st Actuation**

The second actuation was at 16:51:53, alarm panel indicating multi-sensor 53. The fire alarm panel indicates lift lobby, level 3.

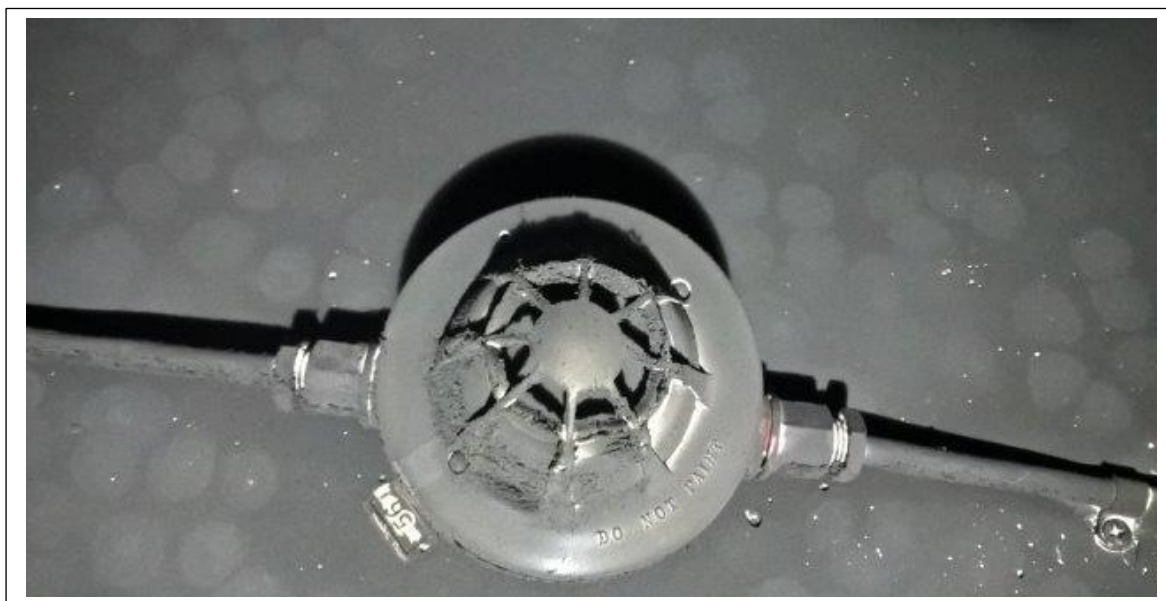
**Figure 3.4.5: Photograph of Multi-sensor in Lift Lobby, Stairwell 2, Level 3**

However, the photograph below was taken in the lift lobby area of stairwell 2, level 3 and clearly shows the number 56, once the products of combustion had been removed from the identity label.

Notwithstanding, it is reasonable to assume that both these locations indicated on the panel are accurate, as the alarm panel indication of a call point on level 3, outside stairwell 3, was the same location that both LCC staff and a member of the public said that they had actuated the break glass point. Secondly, the lift lobby door at stairwell 2, level 3 was sited close to the fire. This door was repeatedly opened by members of the public and staff, allowing the products of combustion into the lobby area, actuating the multi-sensor.

1. LCC are advised to undertake an audit of fire escape doors at all parking locations, to check compliance to BS5839-3 and BS7273-4.
2. Correctly labelled addressable detectors and call points clearly help the responsible persons and Fire and Rescue Services to reduce the time taken to identify the specific location of alarm actuation. A delay to locating a fire can lead to an escalated incident and potentially more severe fire.
3. Where CCTV is used as part of a fire strategy for detecting a fire, it should fulfil the requirements of BS EN 6276 and BS8418 and have adequate numbers of staff to monitor it. If this is not achievable, then alternative and/or additional detection should be considered.

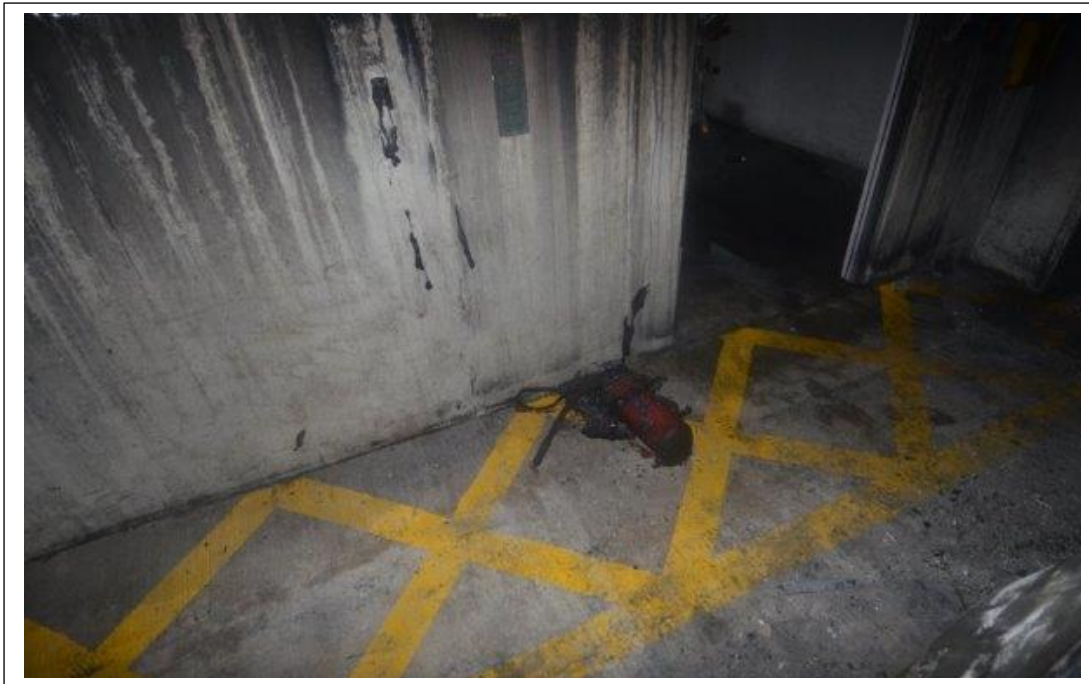
**Figure 3.4.8 Remnants of Fire point, Level 3 Stairwell 3**

Stairwells 3 and 4 are only available on actuation of the fire alarm. The push bar doors are locked by magnetic devices, linked to the alarm panel. These stairwells are not accessible from outside the car park, for security reasons. Members of the public complained of difficulty in opening the emergency escape door to stairwell 3, level 3.

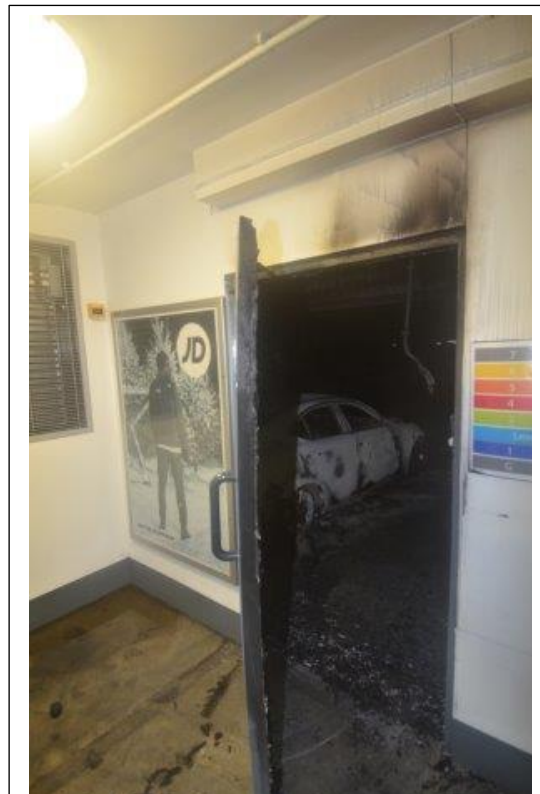
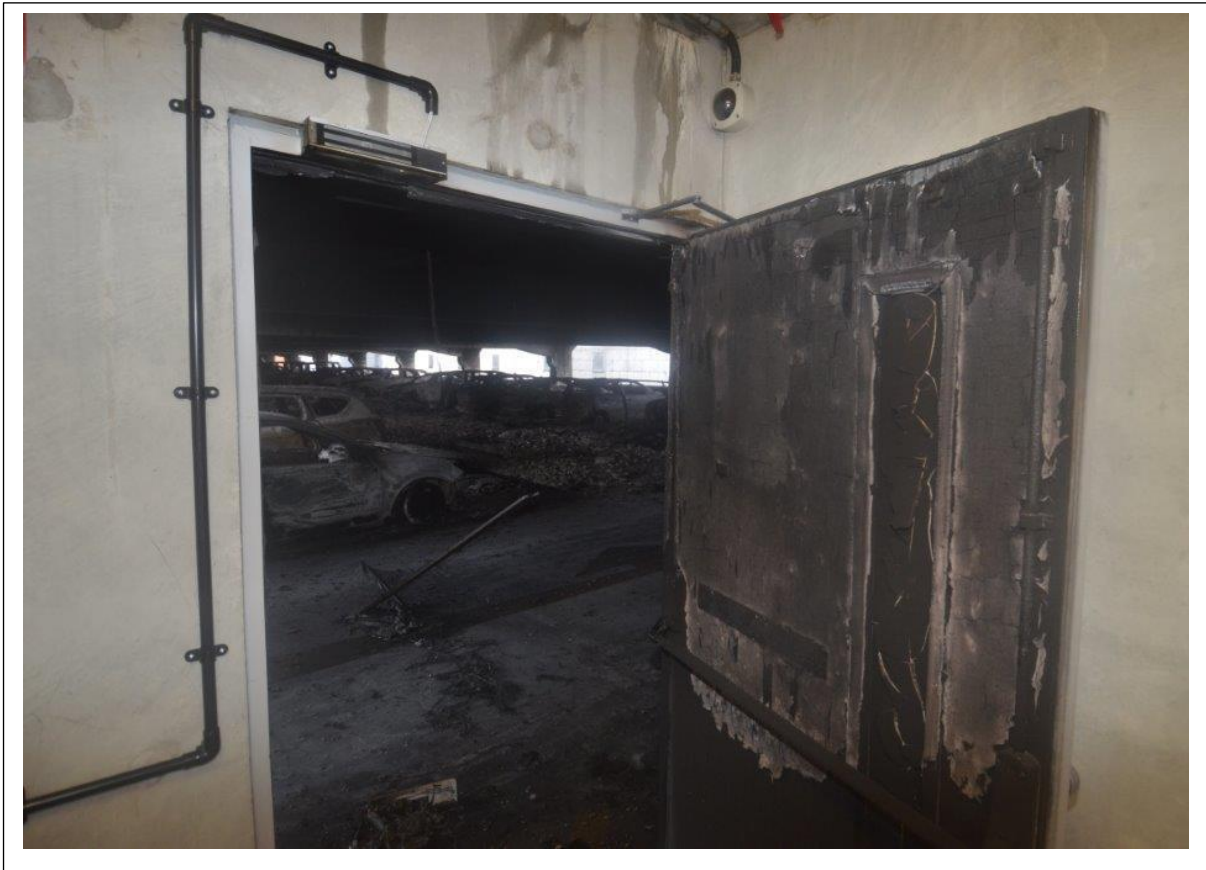
Images 3.4.9 and 3.4.10 are good examples of the effectiveness of the passive fire protection measures in place and how well they performed, despite the severity and intensity of the fire.

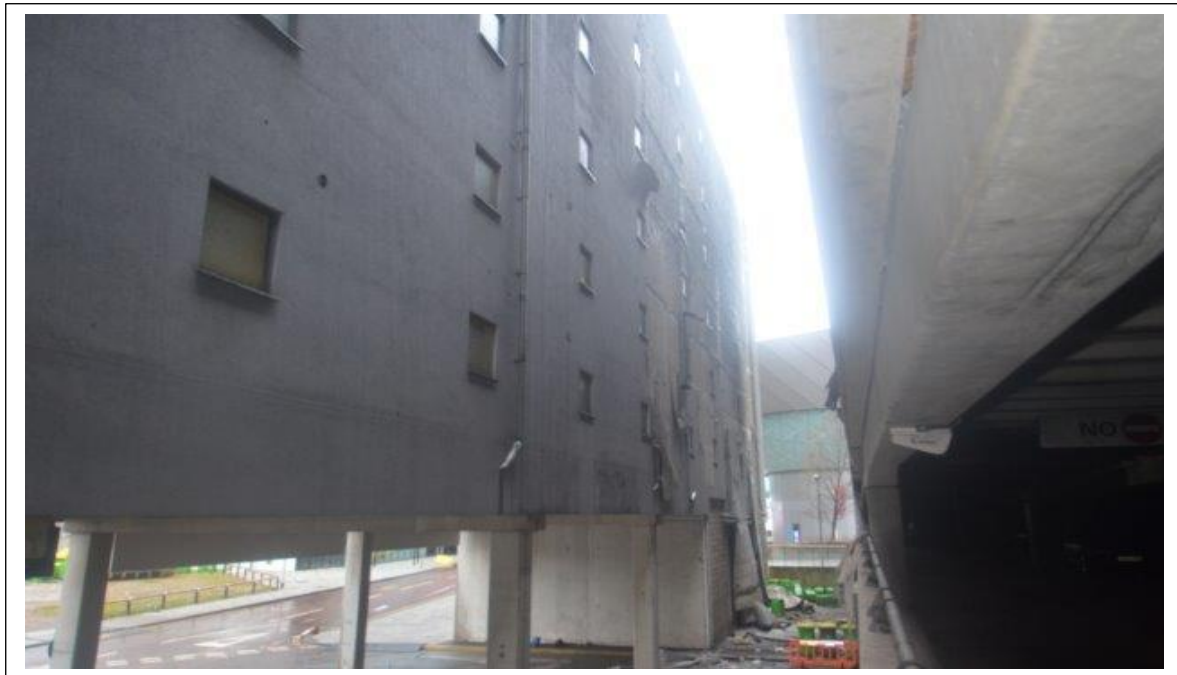
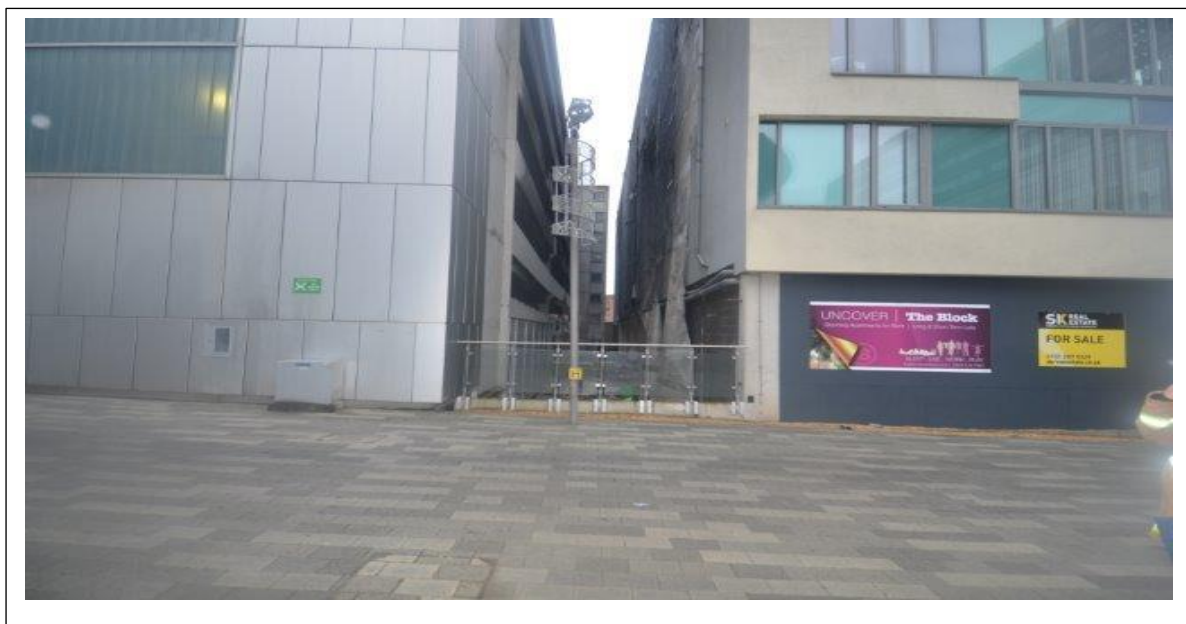
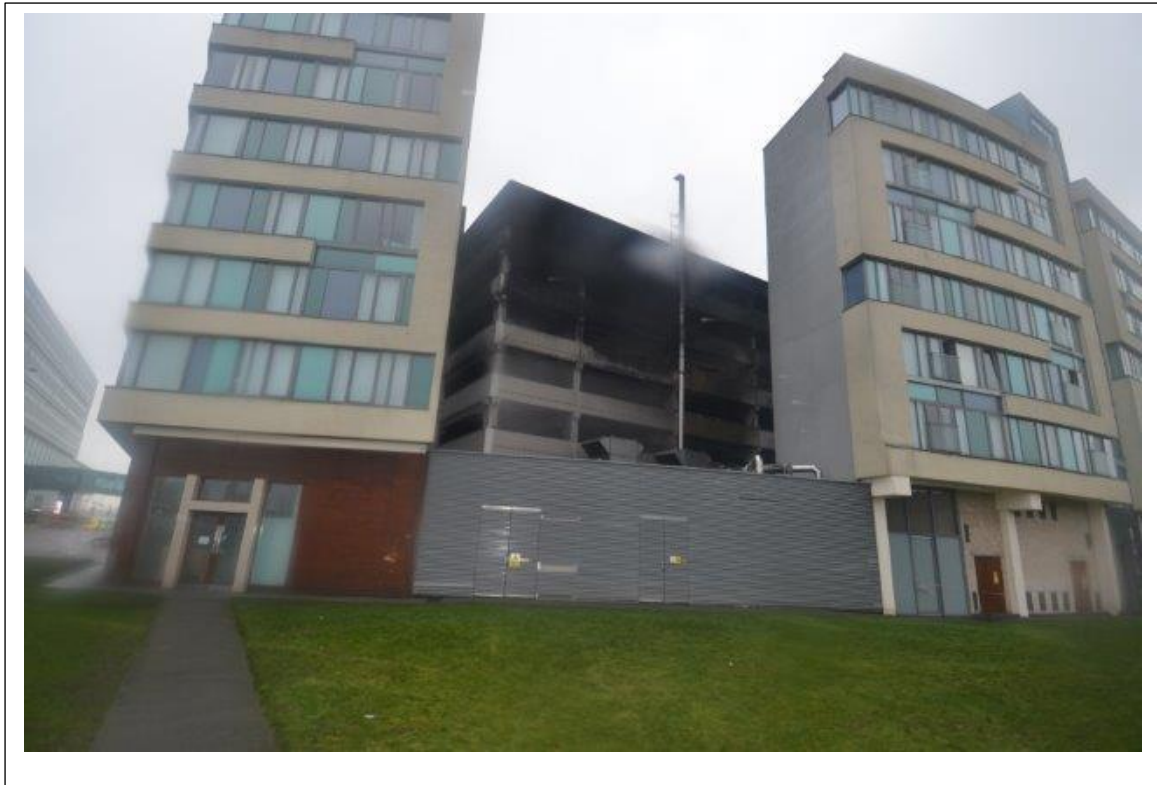
The following images show the severely restricted firefighter appliance access due to the proximity of the serviced apartment building on the southern side of the car park. This negative impact was identified during building regulations submissions and MF&RS insisted on protected stairwells to mitigate this deficiency and accommodate internal firefighting, reaching all levels.

1. Aerial appliance access proved very difficult at this incident and the grilles across the open sides hindered external firefighting. Access and facilities for firefighters at car parks should be reviewed.

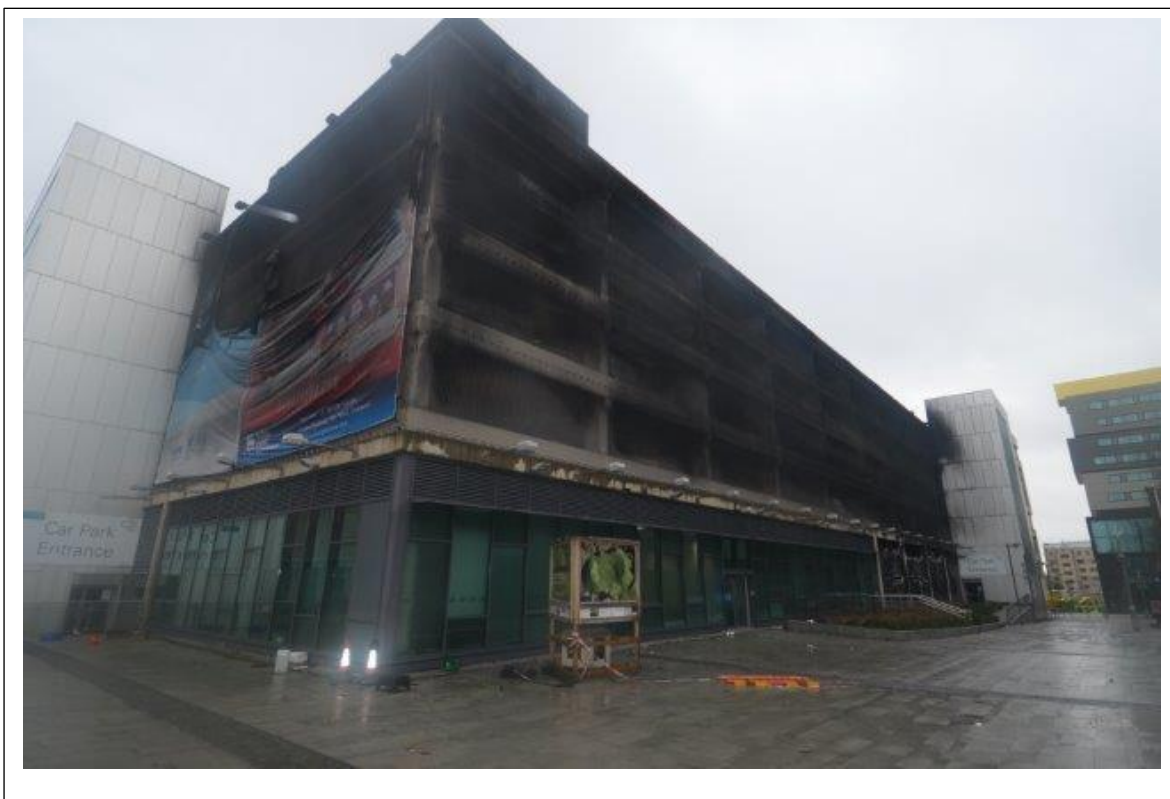
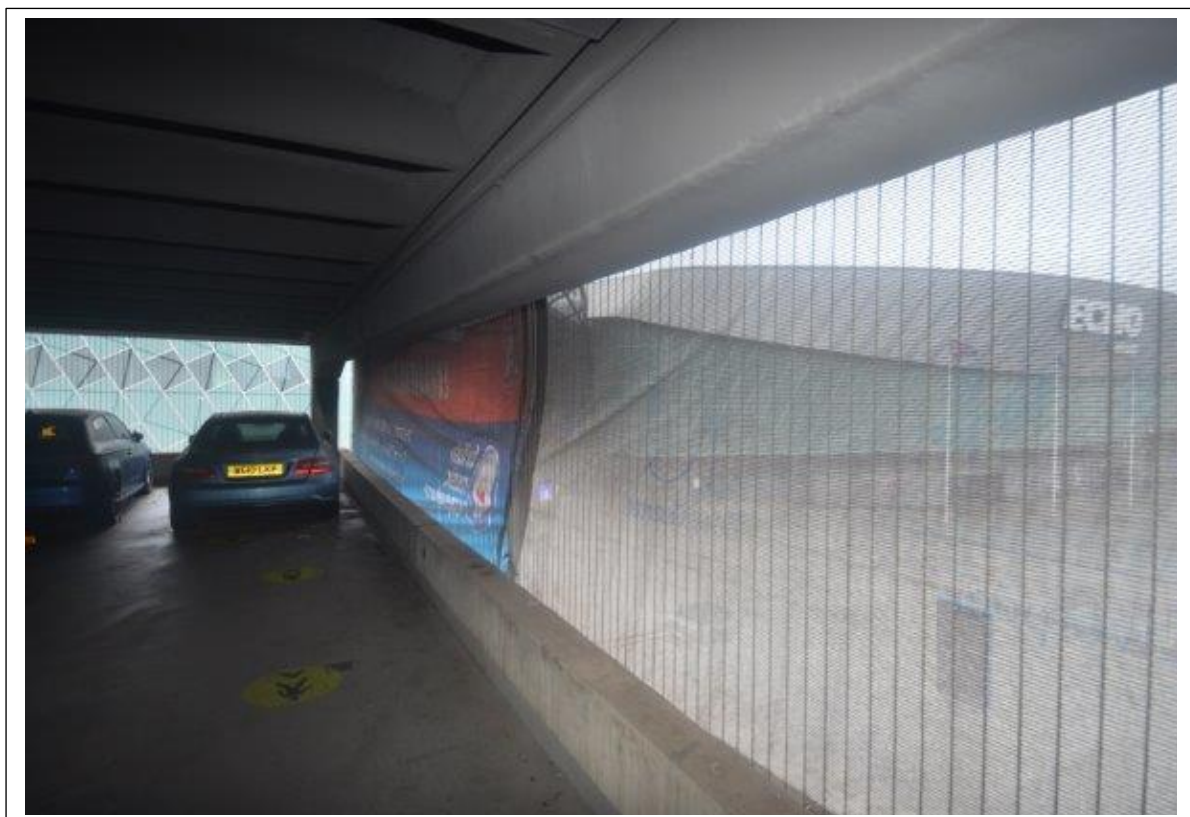
MF&RS took into account an approximate 8% reduction in ventilation caused by the advertising in their calculations and the building still complied with ventilation requirements under ADB Vol.2.

As can be seen from the above photographs (**Figs. 4.1 & 4.2**), the apertures between columns are covered by grilles. These 'Tigris Woven Mesh Panels' cover the apertures from level 3 to level 6 on the northern and western elevations. The free area of these mesh panels is 65 %, according to GKD UK, the PC-Tigris data sheet. This was taken into account by both LCCLABC and MF&RS in their calculations.
