#### Case Study 1: National Library of Scotland

#### Sprinklers in Heritage Buildings:

## Case Study 2: Duff House

### Benefits of Heritage Sprinklers

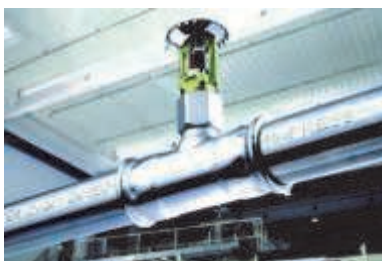
Stainless Steel pipework can be a quick & clean alternative to traditional materials

- stainless steel pipework was used for the system. The **decision to avoid the use of 'black' steel was not taken** lightly- when consideration is given to the problems of corrosion and sludge formation in black steel, it can be seen that the benefits of stainless steel are considerable. In fact, when taking into account reduced labour costs and the cleanliness of the installation it has become increasingly clear that stainless steel is a viable alternative;
- most of the system was prefabricated off-site. This offers many advantages, not the least of which is the elimination of some potentially hazardous processes which would otherwise have to be carried out in proximity to the collections;
- the huge number of joints in the smaller pipes used neoprene seals and were crimped, rather than being formed by brazing, making this element of the work both rapid, clean and safe;

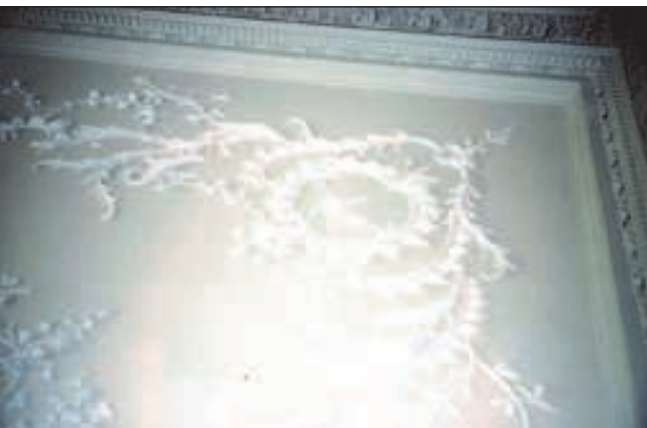
From the illustrations it will be seen that, with care and planning, sprinkler heads can be introduced into sensitive environments here aesthetic considerations are paramount.

The interior architecture determined the type, choice and position of each sprinkler head - for example, in rooms with plain ceilings and deep coombed cornices, sidewall sprinklers were mounted at the base of the cornice. In rooms with more elaborate ceiling decoration, care was taken to install recessed sprinklers (with coloured caps) on the centre line of the decoration.

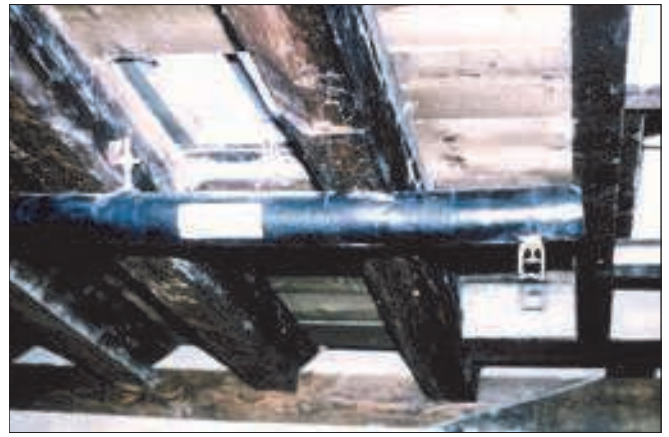
Pipework in unheated area must be protected from frost. This is easily achieved by using trace-heating and thermo insulation along the length of the pipe.

In the design process care was taken to ensure that where sprinkler pipes were likely to be exposed to extremes of temperature such as in the attic spaces full insulation and trace heating were incorporated in the design.
