**Sprinkler Protected Car  
Stacker Fire Test**

Prepared for: The British  
Automatic Fire Sprinkler  
Association

11 December 2009

Client report number 256618

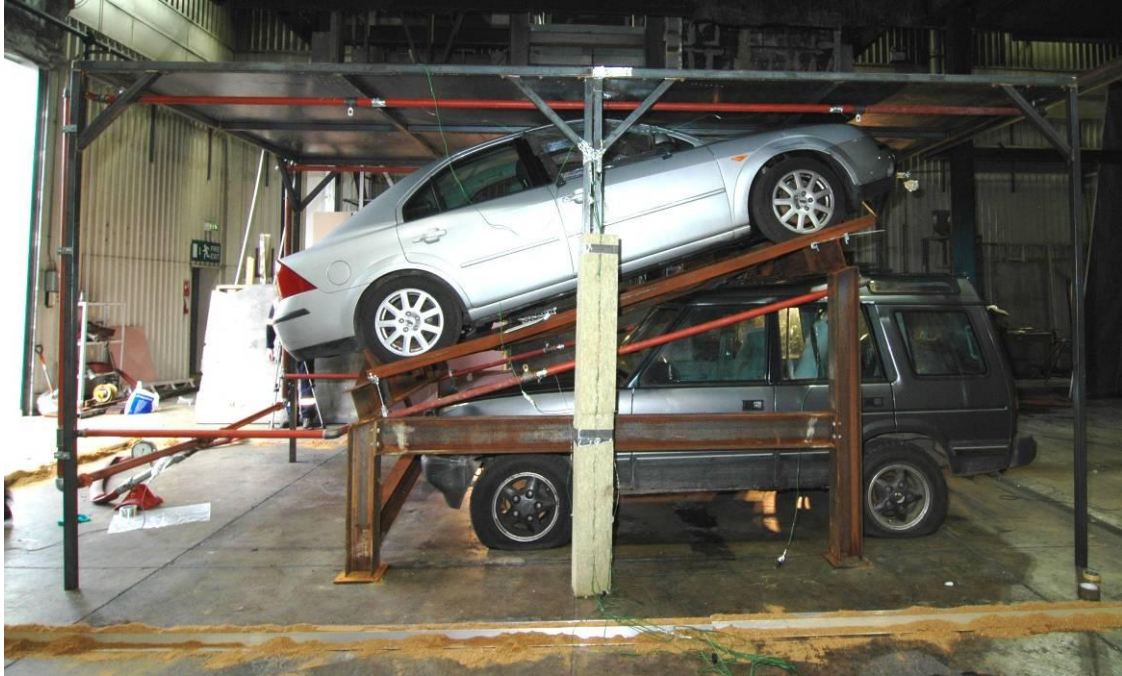
Figure 3 – Photograph showing test arrangement and sprinkler head positions (east side).

The installed system for the test is shown in Figure 1, Figure 2, Figure 3 and Figure 4.

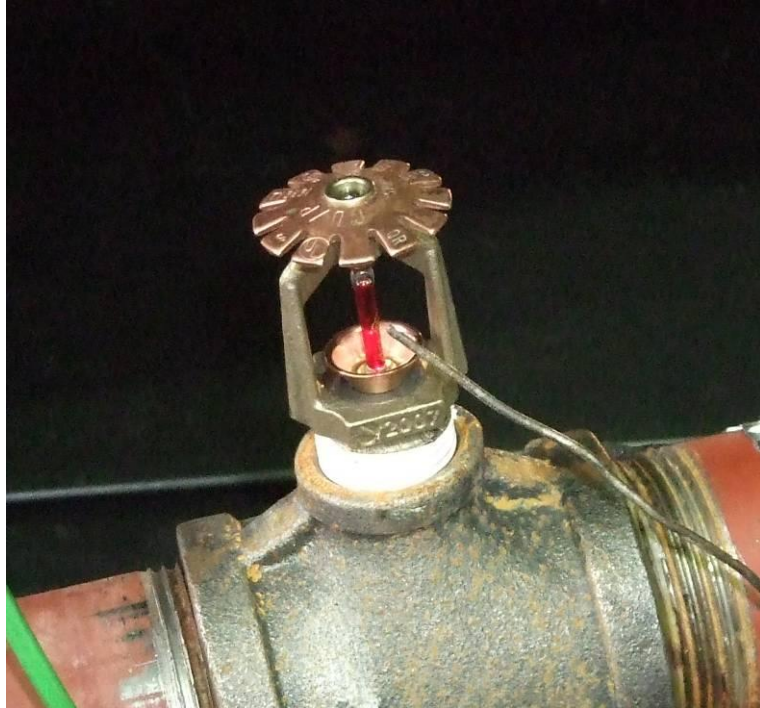
**Figure 6 – Sprinkler head selected for testing**

The sprinkler head used was a Tyco TY363-1-155 conventional sprinkler head. This sprinkler head had a K-factor of 80 with a quick response frangible bulb rated at 68 °C, approved by the Loss Prevention Certification Board (LPCB Ref. No. 094a/06 & 007k/04) as Quick Response.

Based on the findings of the cold discharge testing, a 'conventional' sprinkler model was selected as providing an optimised water discharge profile for the hazard. The heads at high level were installed in the pendent orientation and the intermediate heads in the upright orientation. The sprinkler selected for the tests is shown in Figure 6.

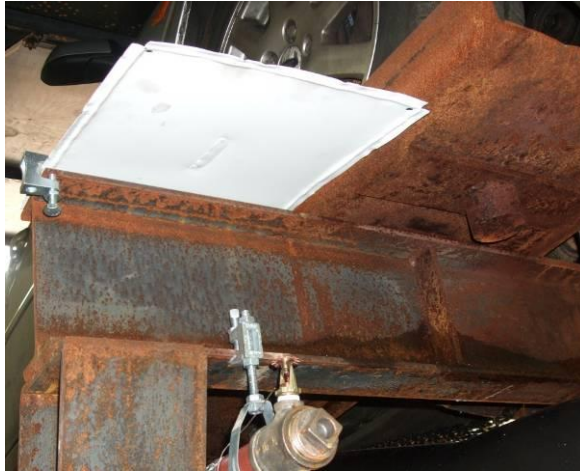
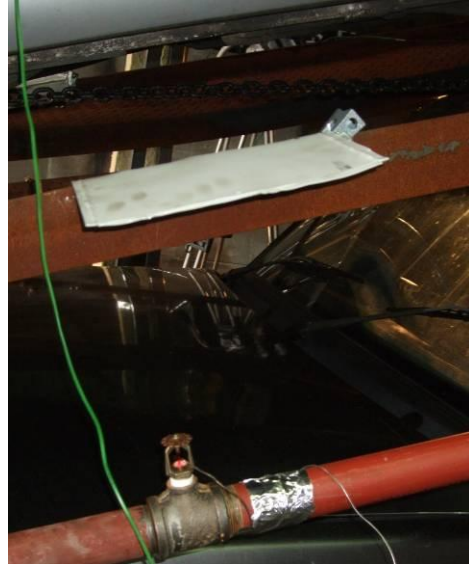
**Figure 7 – Baffle plate installed above intermediate sprinkler head**

It became apparent during the water testing that the intermediate level sprinkler heads were becoming wetted by the operation of the high level sprinklers. The BAFSA sprinkler system providers therefore installed a 'baffle plate' above each of the intermediate heads in an attempt to protect the sprinklers from direct water impingement, see Figure 7. However, the ability of the plates to prevent the heads from becoming wet was not clearly demonstrated (or assessed by BRE Global) during this trial phase.

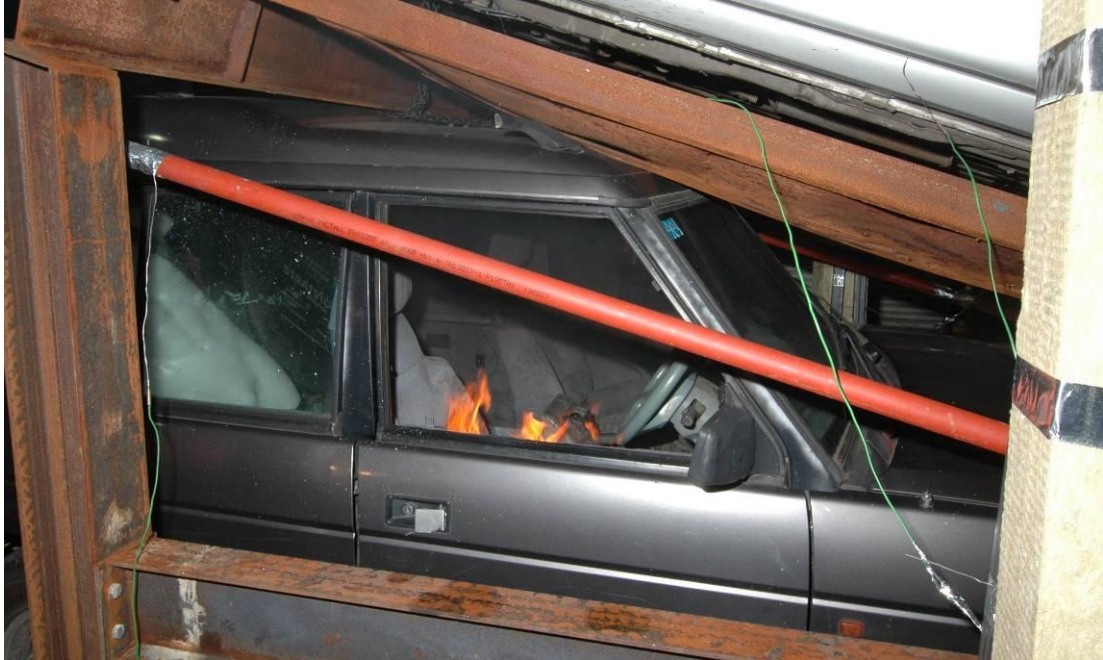
**Figure 8 – Test in progress; 3 minutes 33 seconds from ignition**

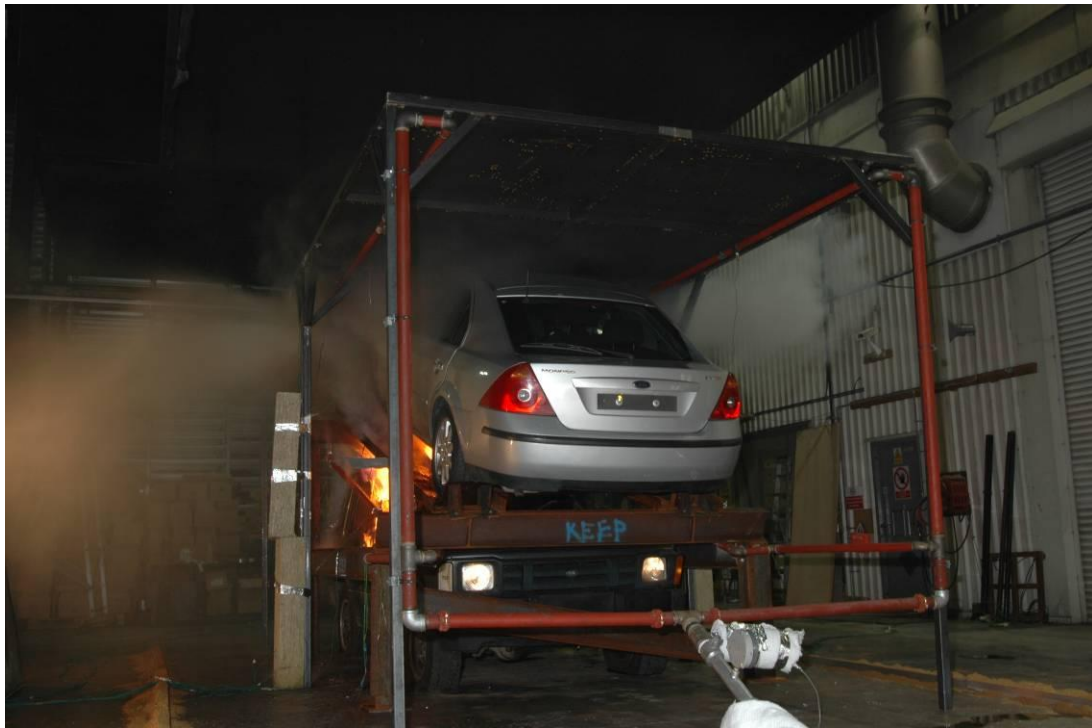
**Figure 9 – Test in progress; 13 minutes 19 seconds from ignition**

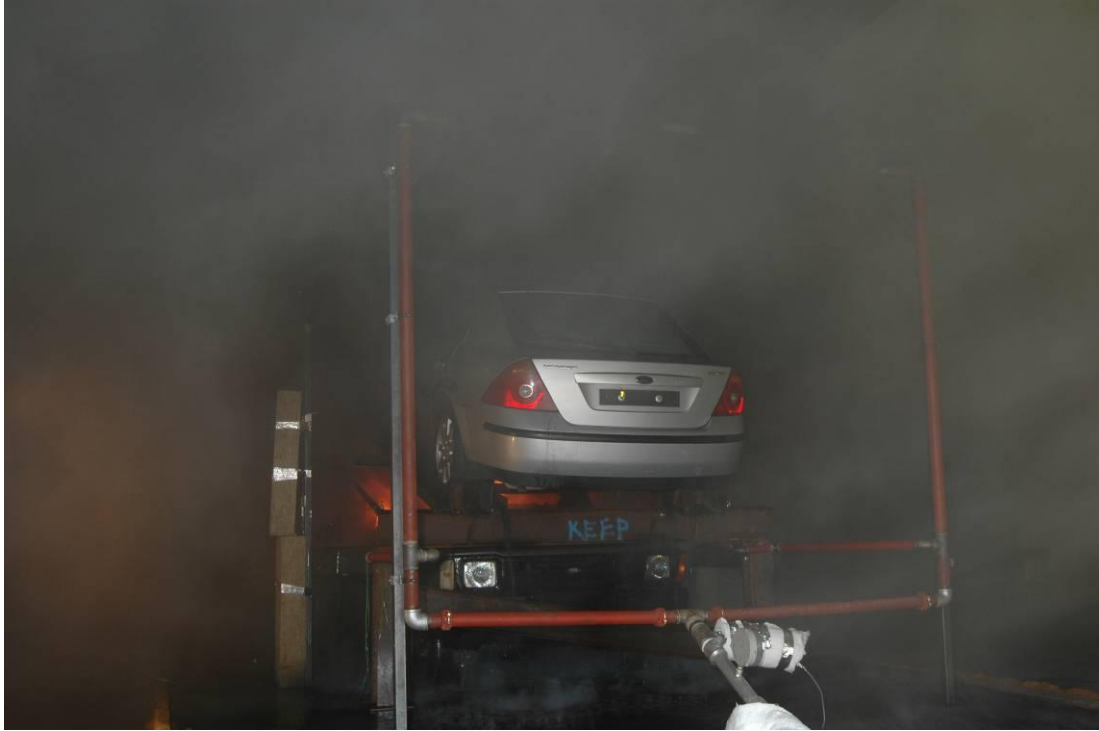
**Figure 10 – Test in progress; 22 minutes 51 seconds from ignition**

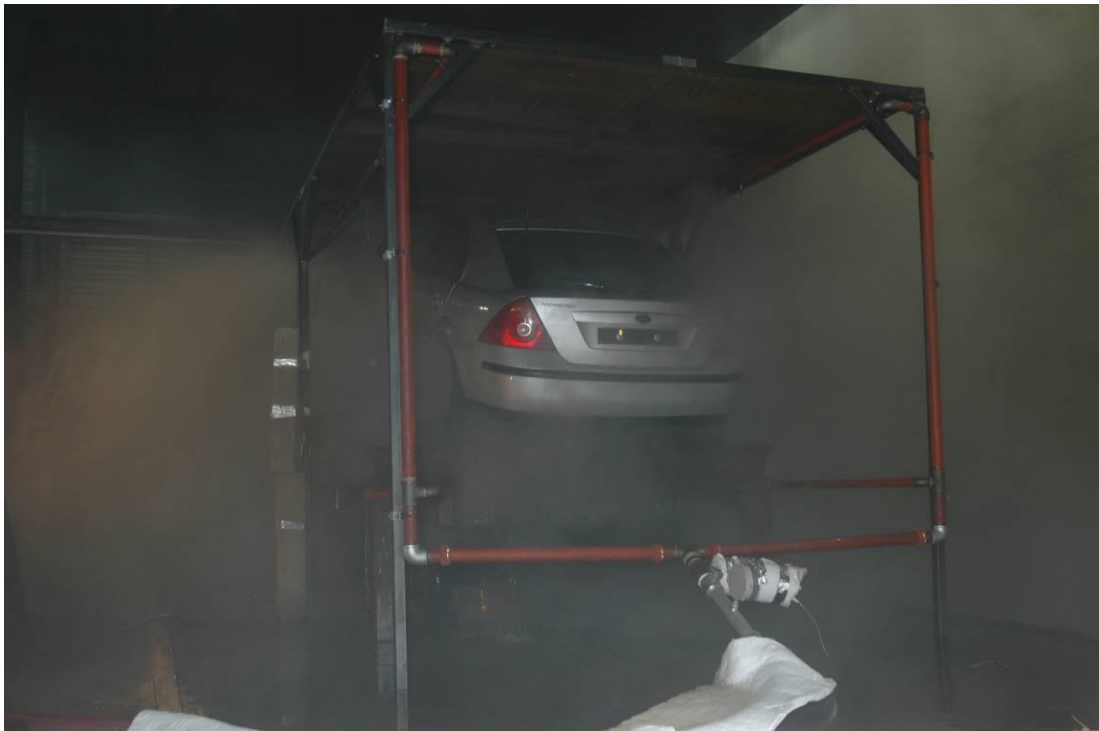
**Figure 11 – Test in progress; 57 minutes 45 seconds from ignition**

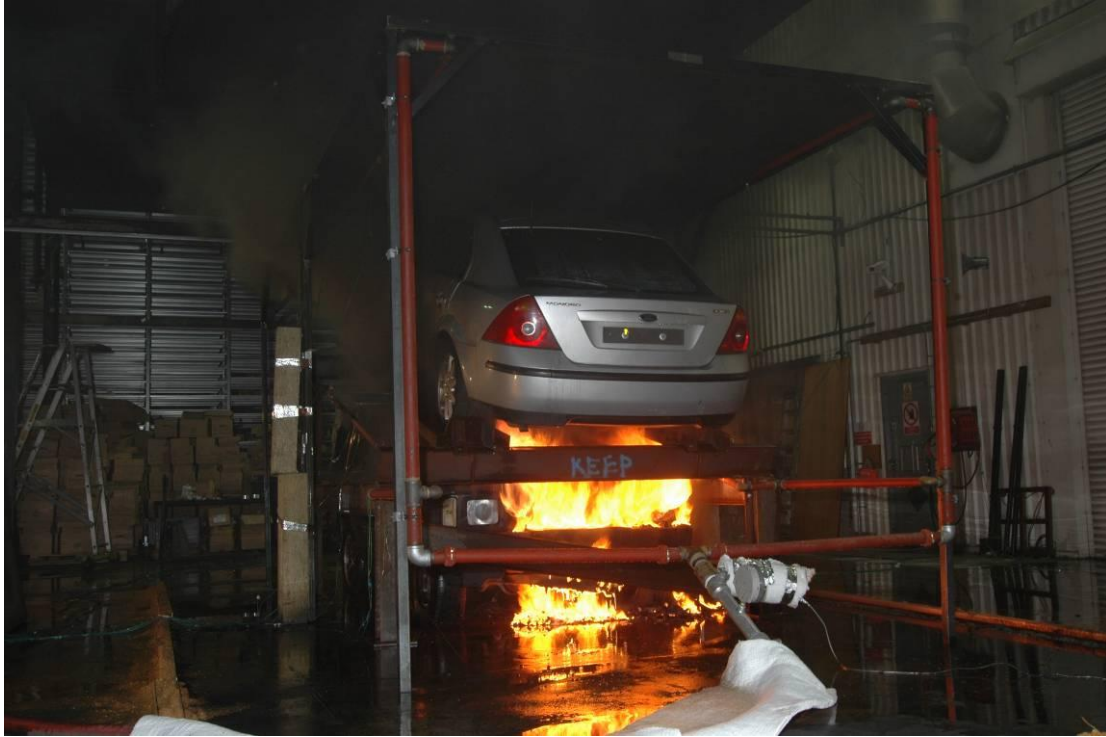
**Figure 12 – Test in progress; 1 hour 23 minutes 9 seconds from ignition (sprinkler system off)**

- I After one hour of operation the sprinkler system was turned off. A fire grew in both the lower and upper cars, showing that these fires had been controlled but not extinguished by the sprinkler system. The sprinkler system was then reactivated and again rapidly controlled and contained the fire to within the body envelope of each car.

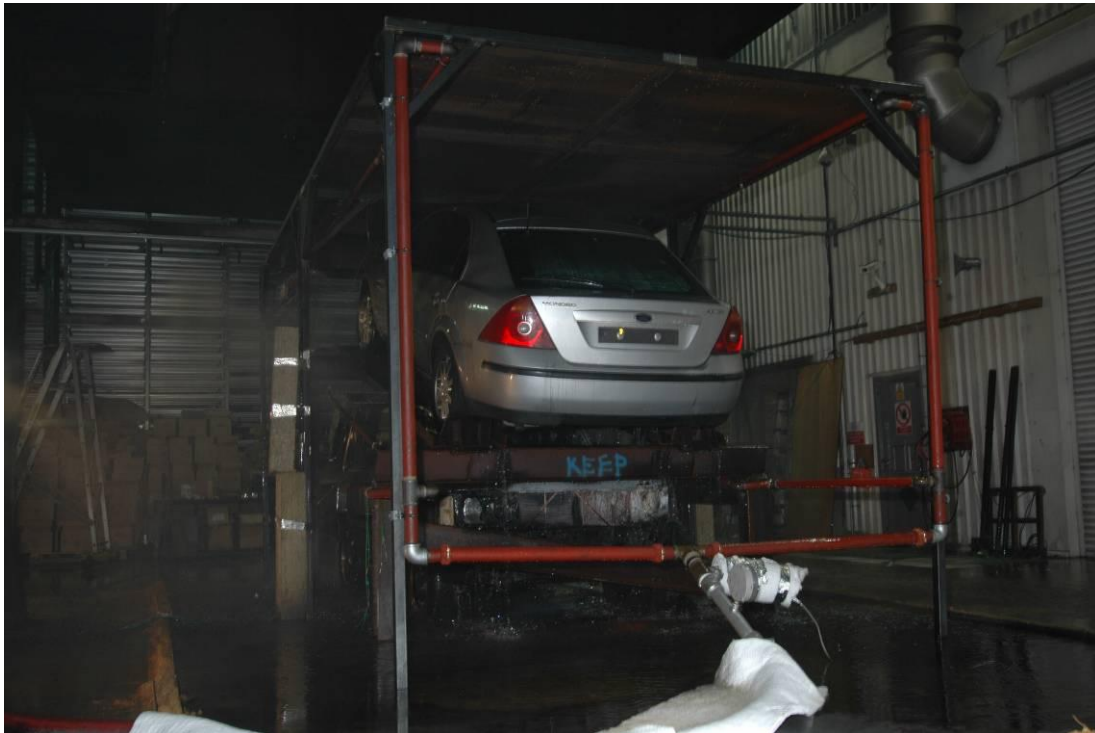
**Figure 13 – Test in progress; 1 hour 34 minutes 58 seconds from ignition**

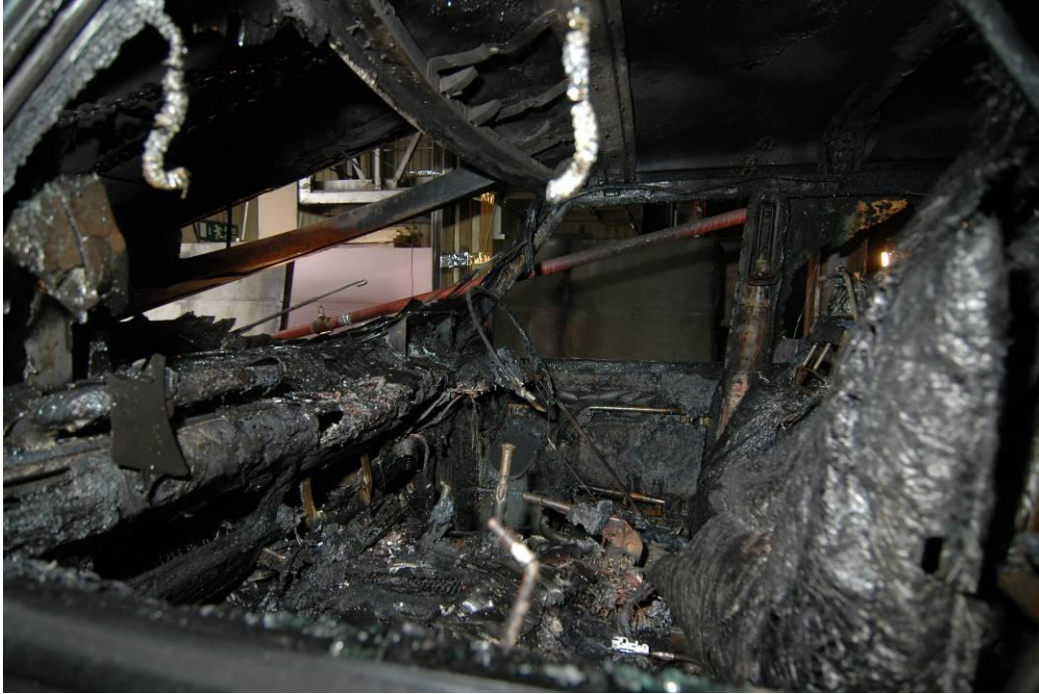
**Figure 14 – Damage to interior of Land Rover (lower car)**

After the test, examination of the vehicles indicated that the majority of the combustible materials in the Land Rover had been consumed or severely affected by fire. The Ford Mondeo had suffered significant damage to its engine bay. However, the interior of this car had not been affected by the fire.

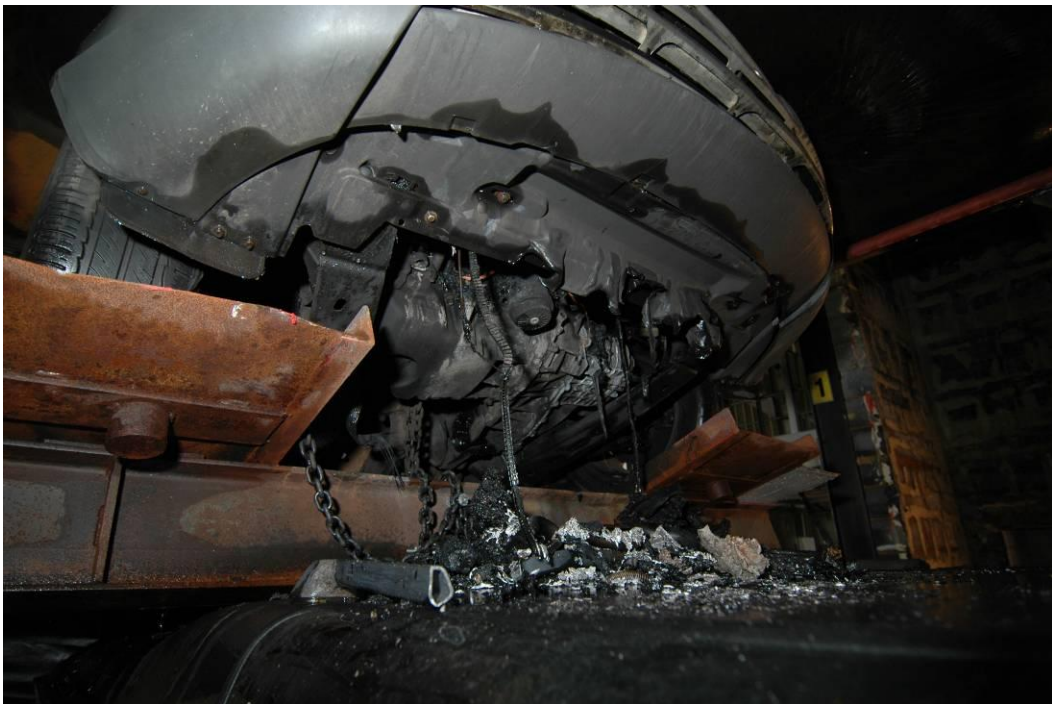
**Figure 15 – Damage to underside and engine bay of Ford Mondeo (upper car)**

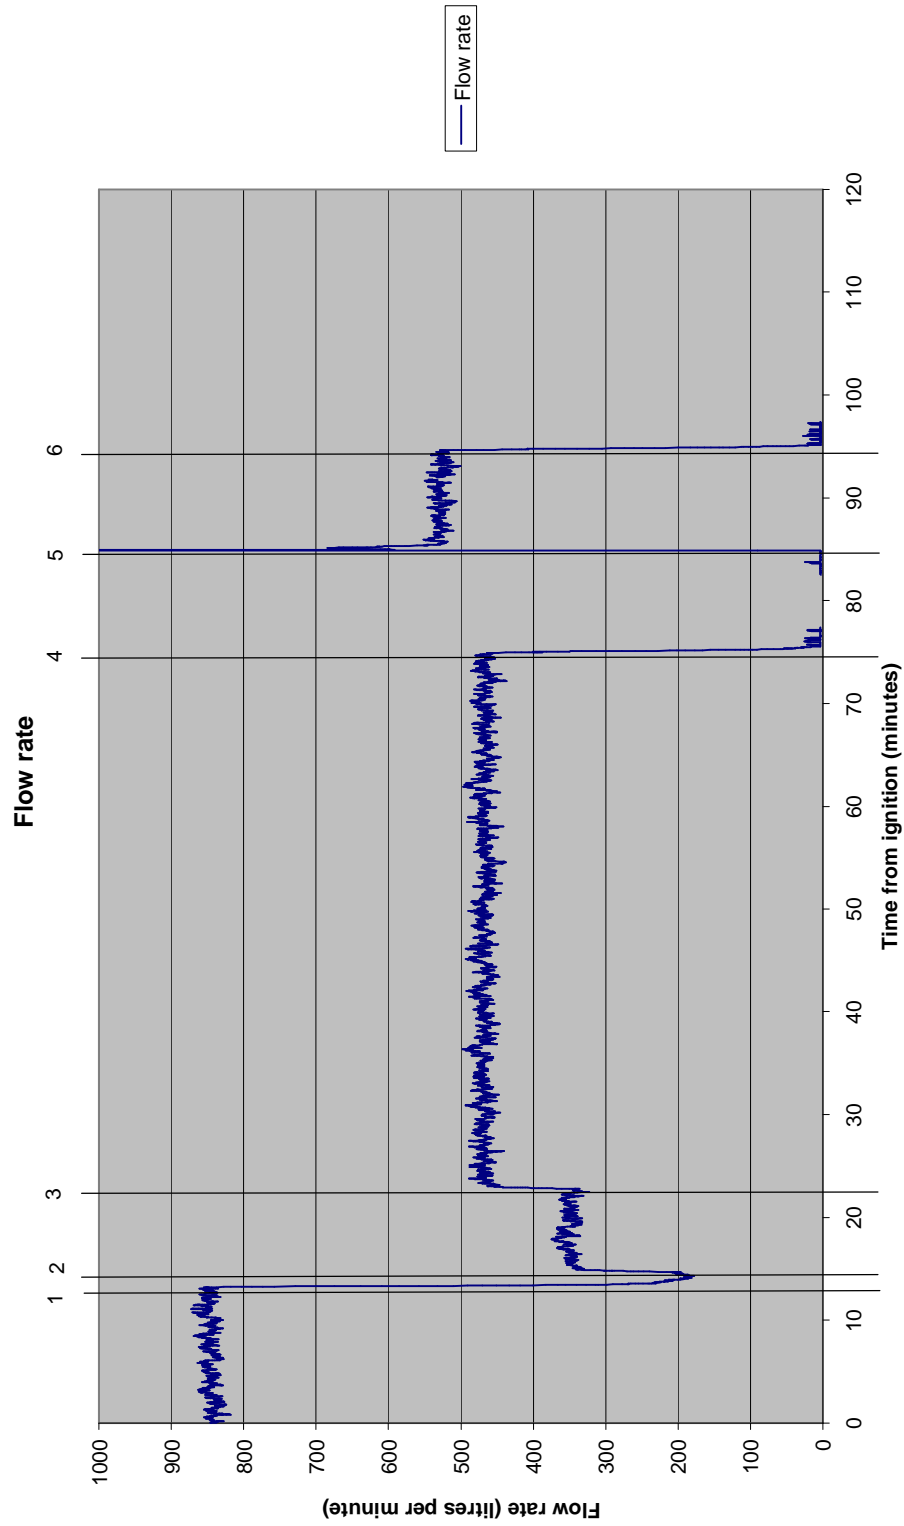
Figure 17 – System total flow rate

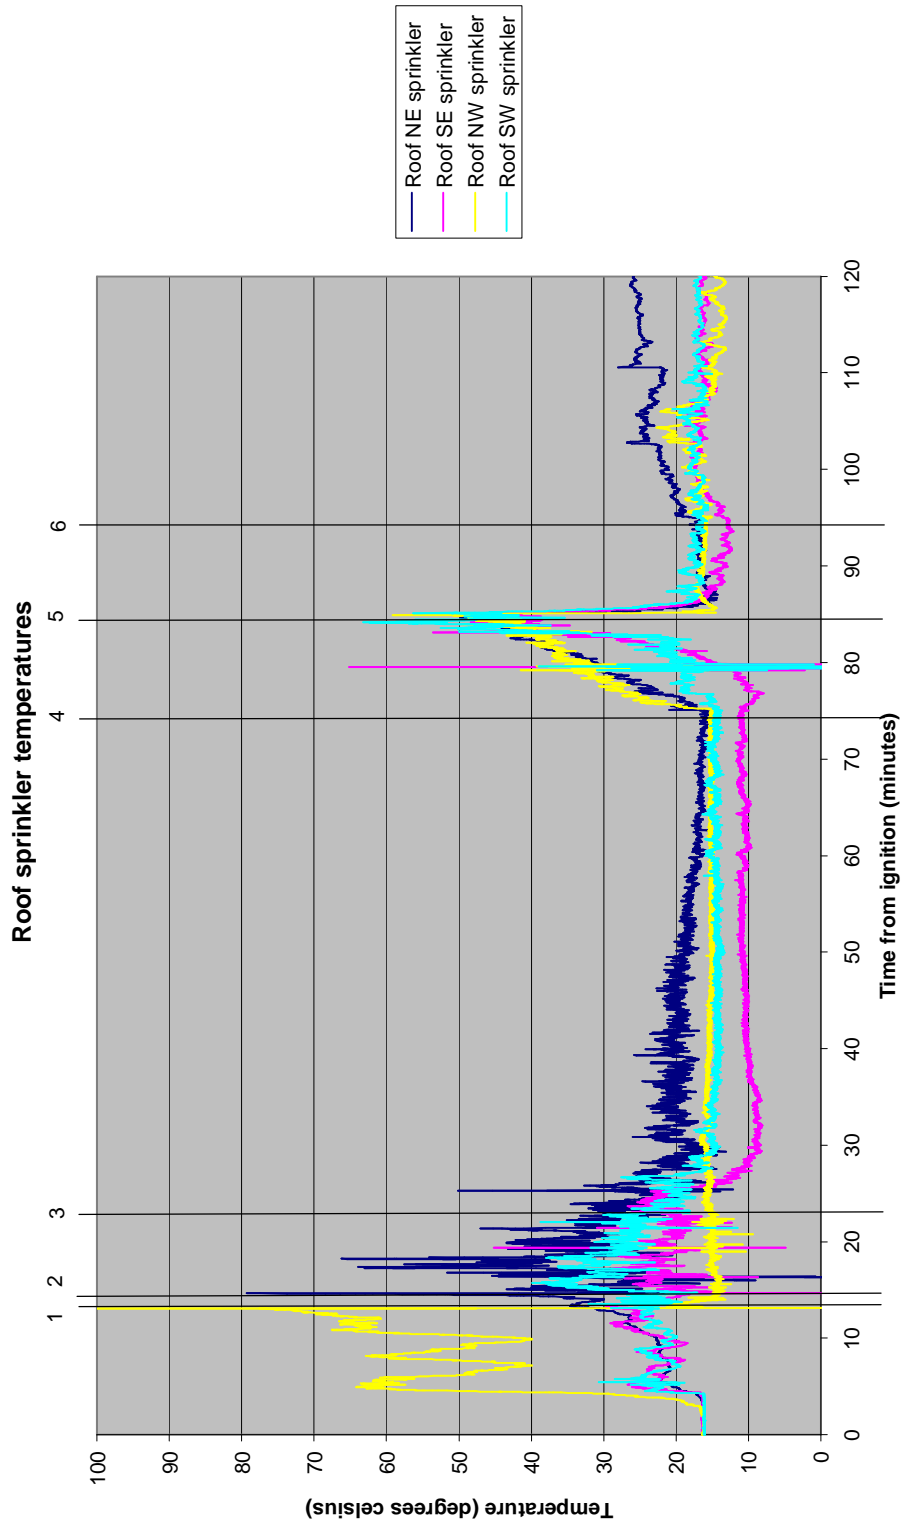
Figure 18 – Temperatures of the roof sprinklers

Note that the fluctuations on the temperature data are typical of sprinkler tests and tend to occur when thermocouples are wetted.

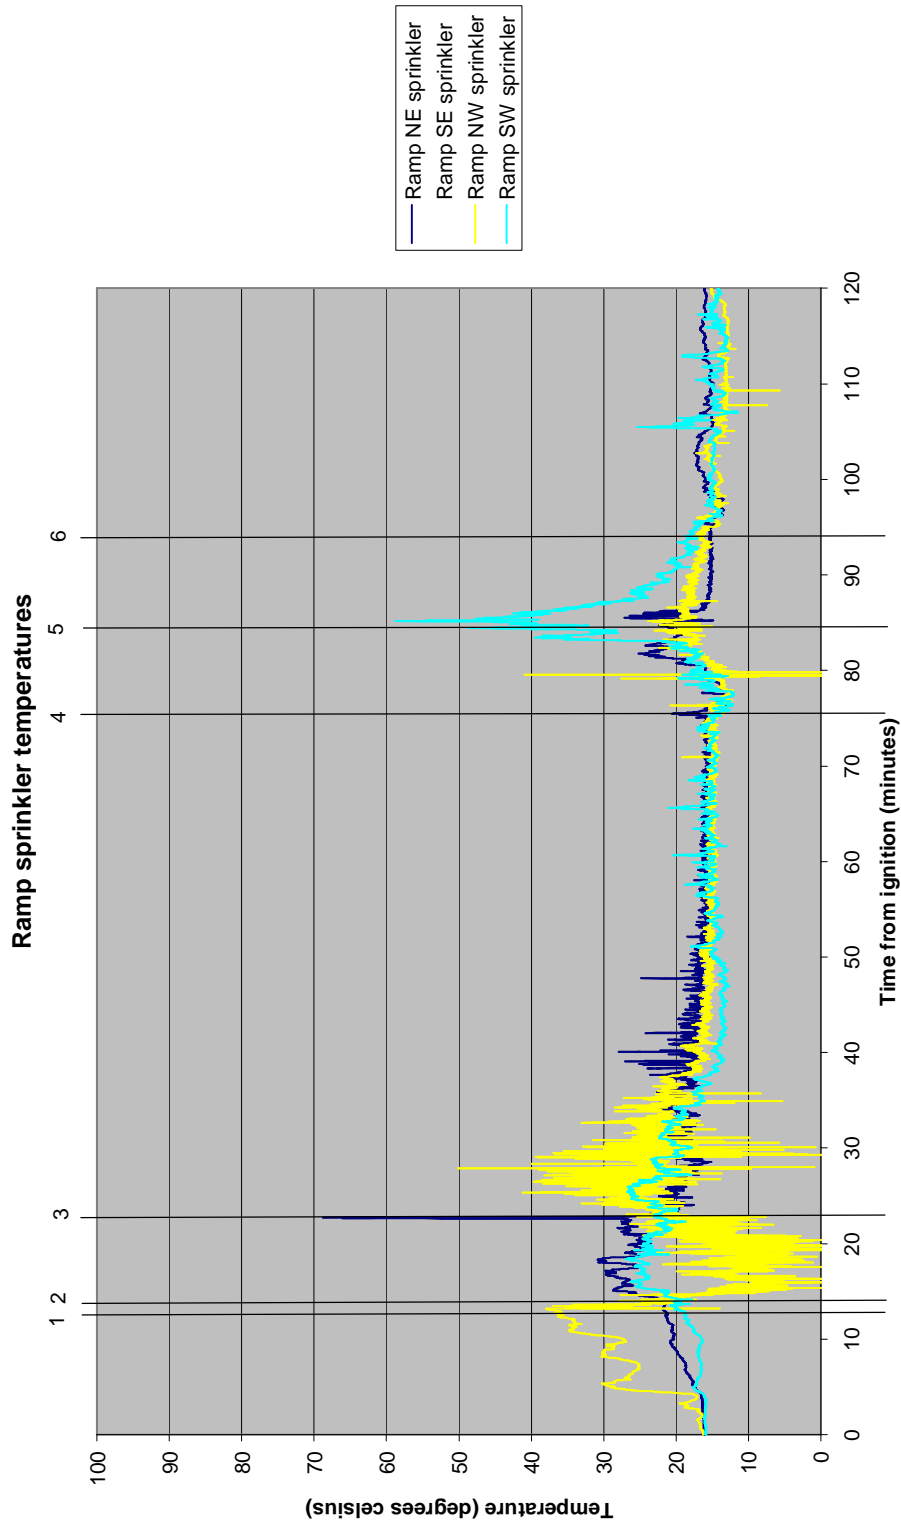
Figure 20 – Temperatures of the ramp sprinklers without ramp SE sprinkler

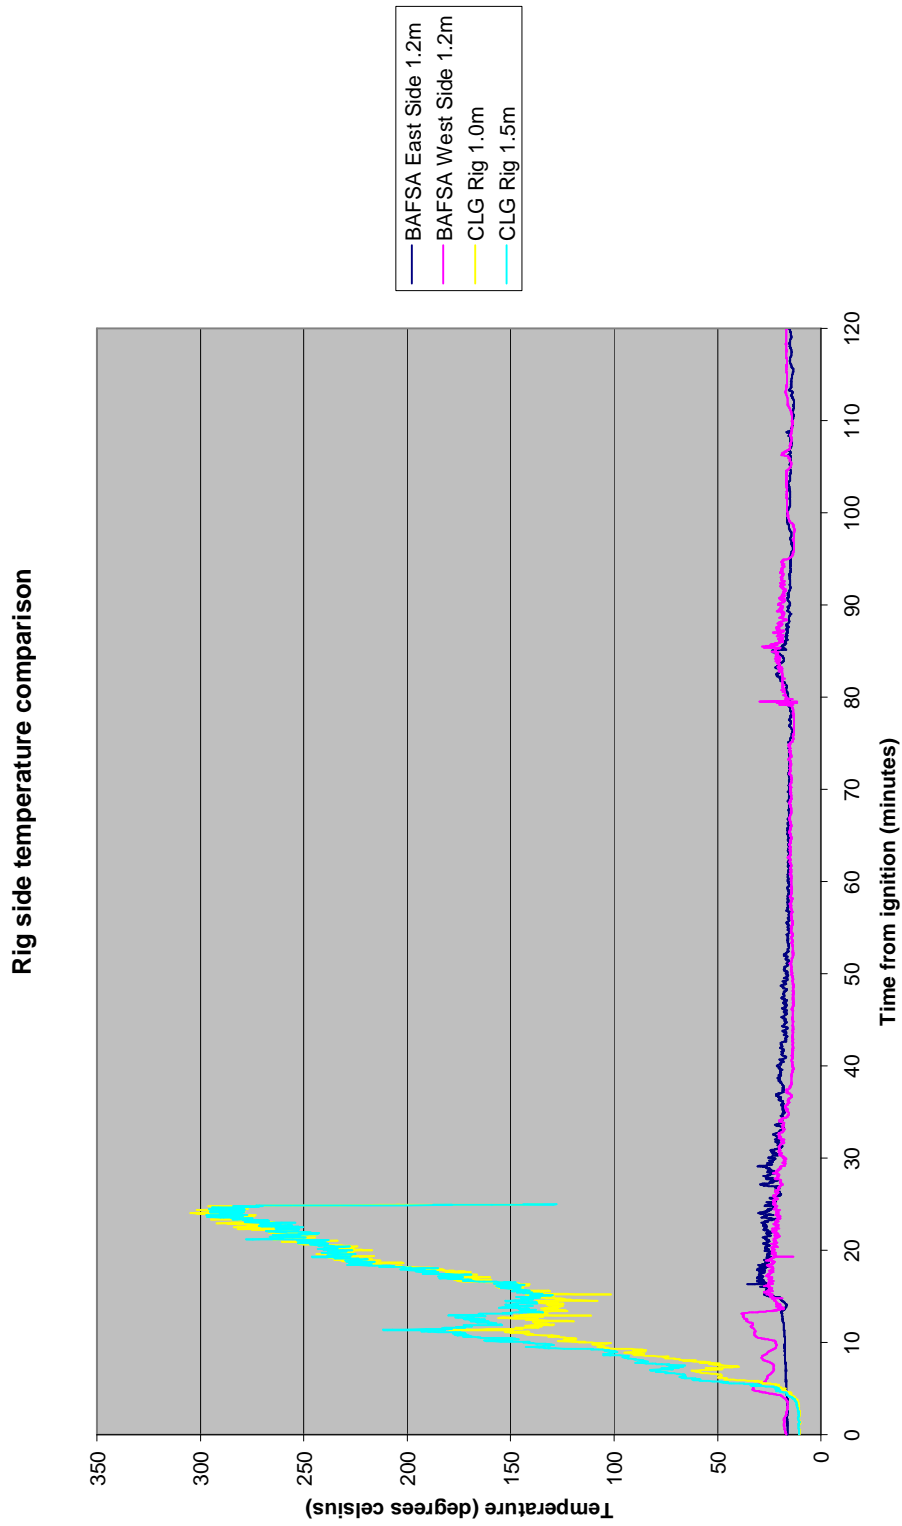
Figure 25 – Comparison between rig side temperatures during CLG and BAFSA tests

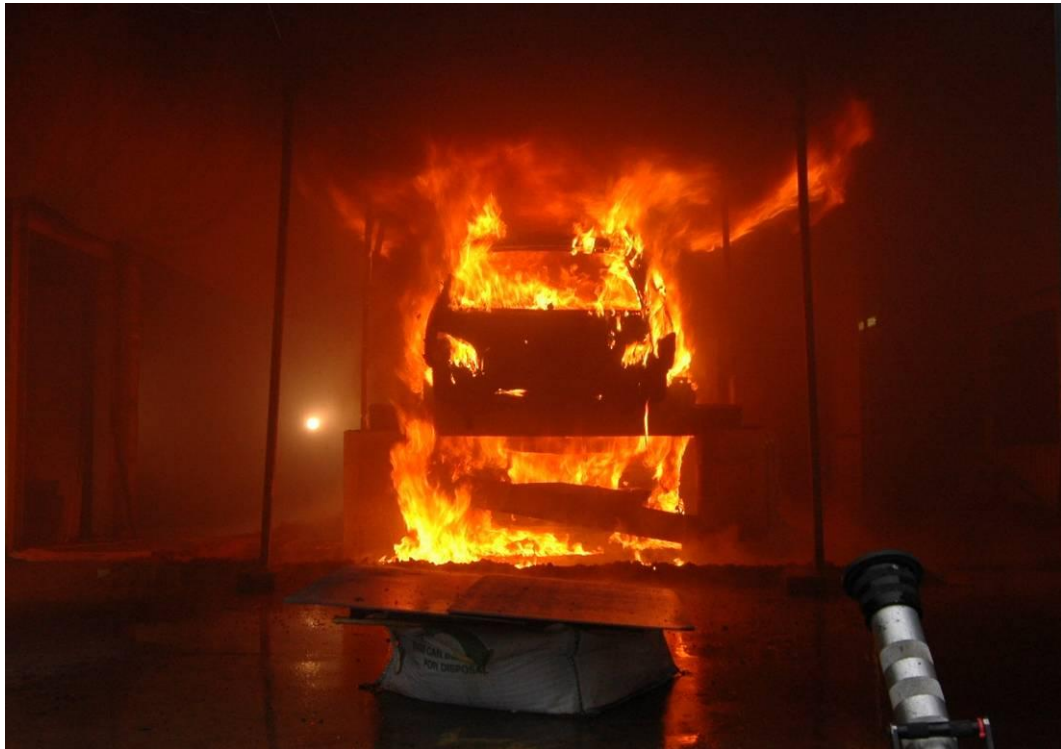
**Figure 27 – CLG test in progress; 20min 59secs from ignition**

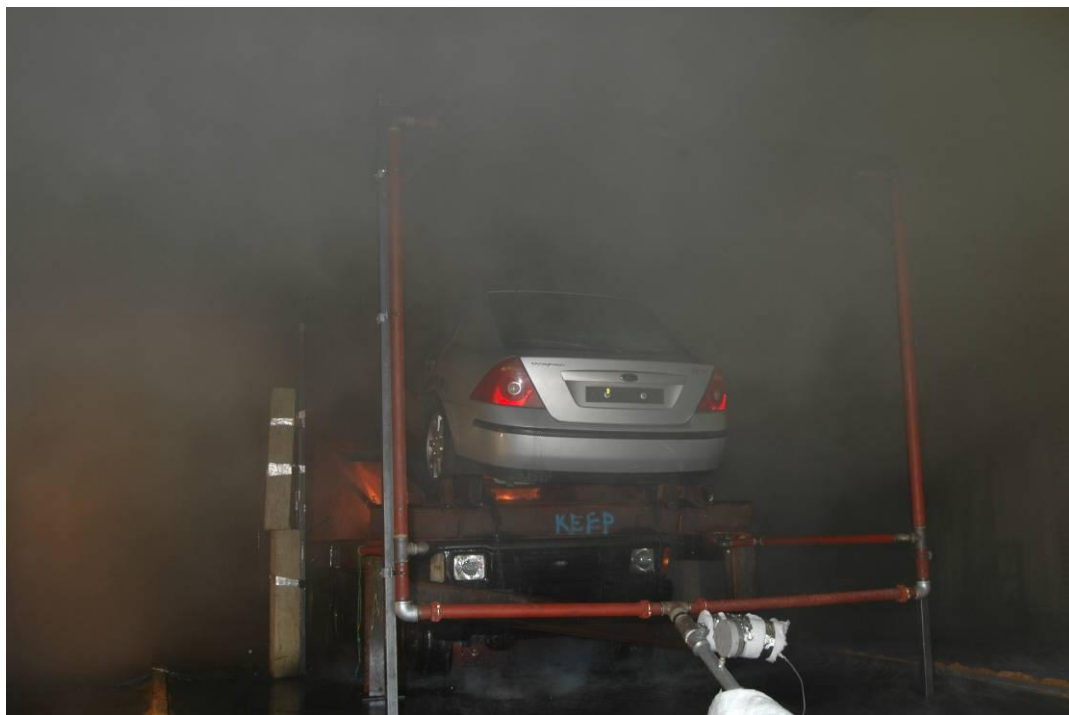
**Figure 28 – BAFSA test in progress; 20 minutes 53 seconds after ignition**

- I The sprinkler system resulted in substantial “fogging” and reduced the visibility of the fire compared with the CLG test.
- I Whilst the fire did spread to the upper vehicle, the upper vehicle did not become fully involved, so it is the opinion of BRE Global that the risk of fire spread beyond the test geometry (vertically or horizontally) to other nearby cars is significantly reduced by the presence of a sprinkler system.
