West Hampstead Square, Automatic Fire Suppression System Activation Case Study

Date of incident: Tuesday 3 July 2018

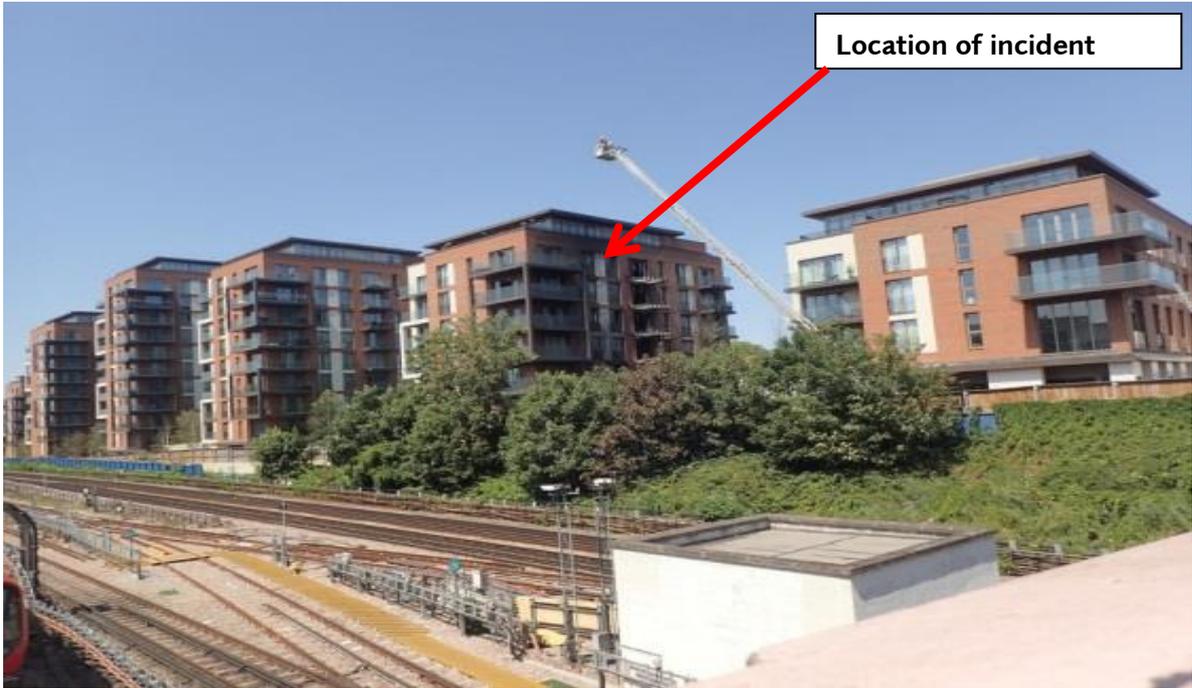
- 3.1 The development comprises of seven individual residential buildings ranging in height between 14m (5 floors) and 35m (12 floors) and has been occupied since 2016.
- 3.2 The buildings within the development are constructed as follows :
 - Traditional reinforced concrete frame/brickwork.
 - Triple glazed aluminium tilt and turn windows/doors.
 - Balconies constructed of steel frame with aluminium fascia and composite decking and plastic soffits with toughened balustrade glazing.
 - Podium levels.

3.3 This report will be focusing on the Orwell building only.

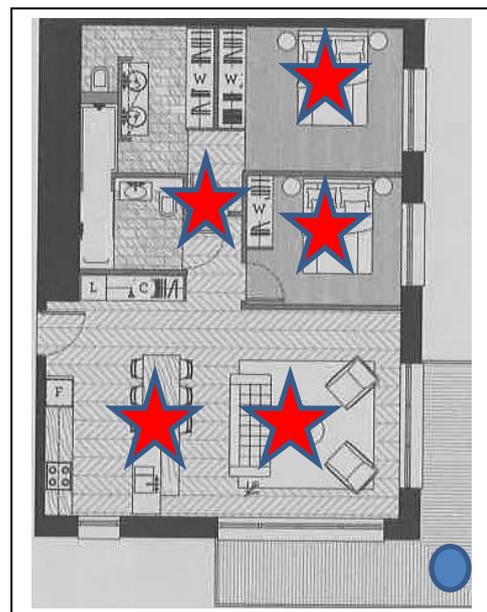
Location of nozzle heads

3.4 Typical layout of apartment/location nozzle heads, the three bedroom apartments were not involved in the fire.

3.5 Dimensions 2 bedroom flat

- Internal area:- 77.8 sqm
- Living area:- 7700 x 4500mm
- Bedroom 1:- 3400 x 3150 mm
- Bedroom 2:- 2800 X 2790 mm
- Balcony:- 13.9sqm

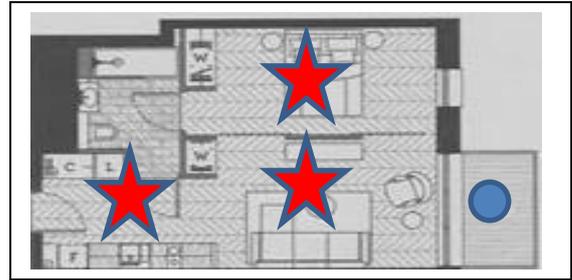
3.6 Dimensions Suite/Studio

- Internal area:- 41.4sqm
- Living area:- 6600 x 3080 mm
- Bedroom:- 4290 x 2500 mm
- Balcony:- 3.9sqm

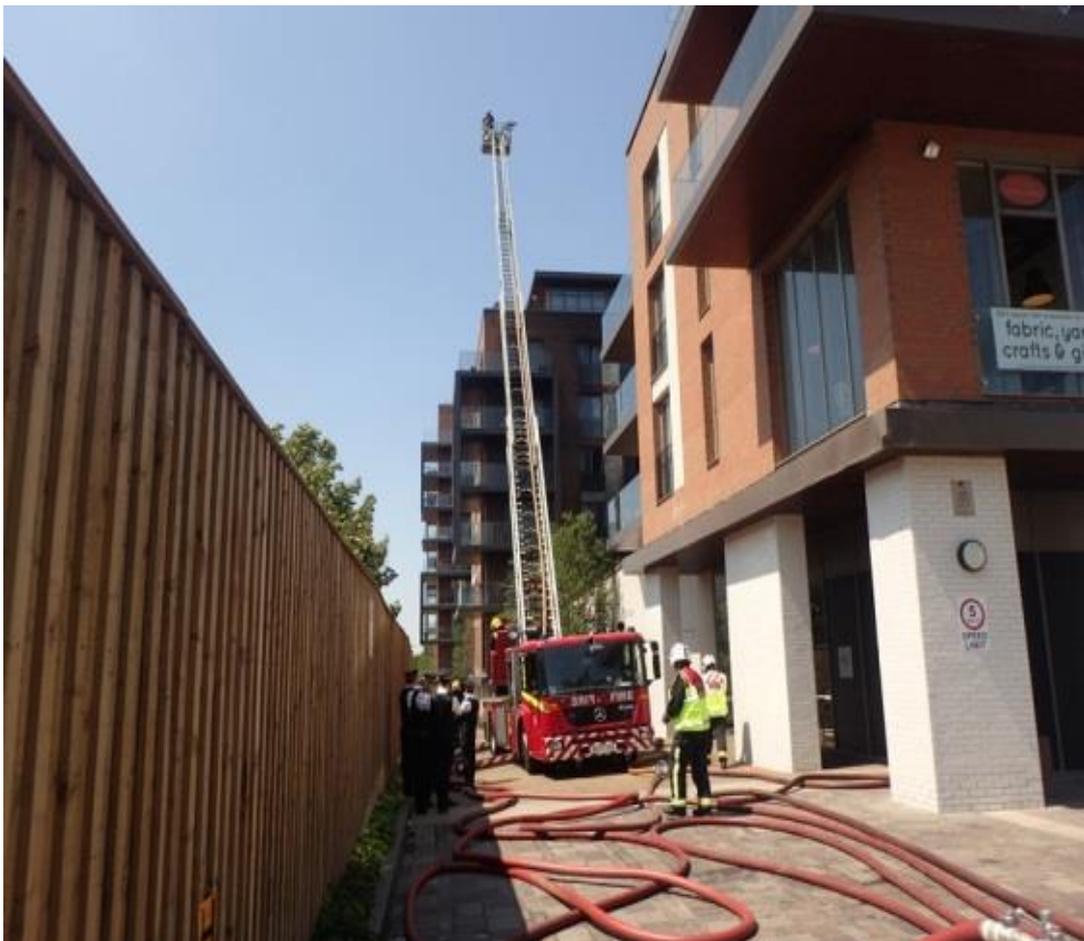
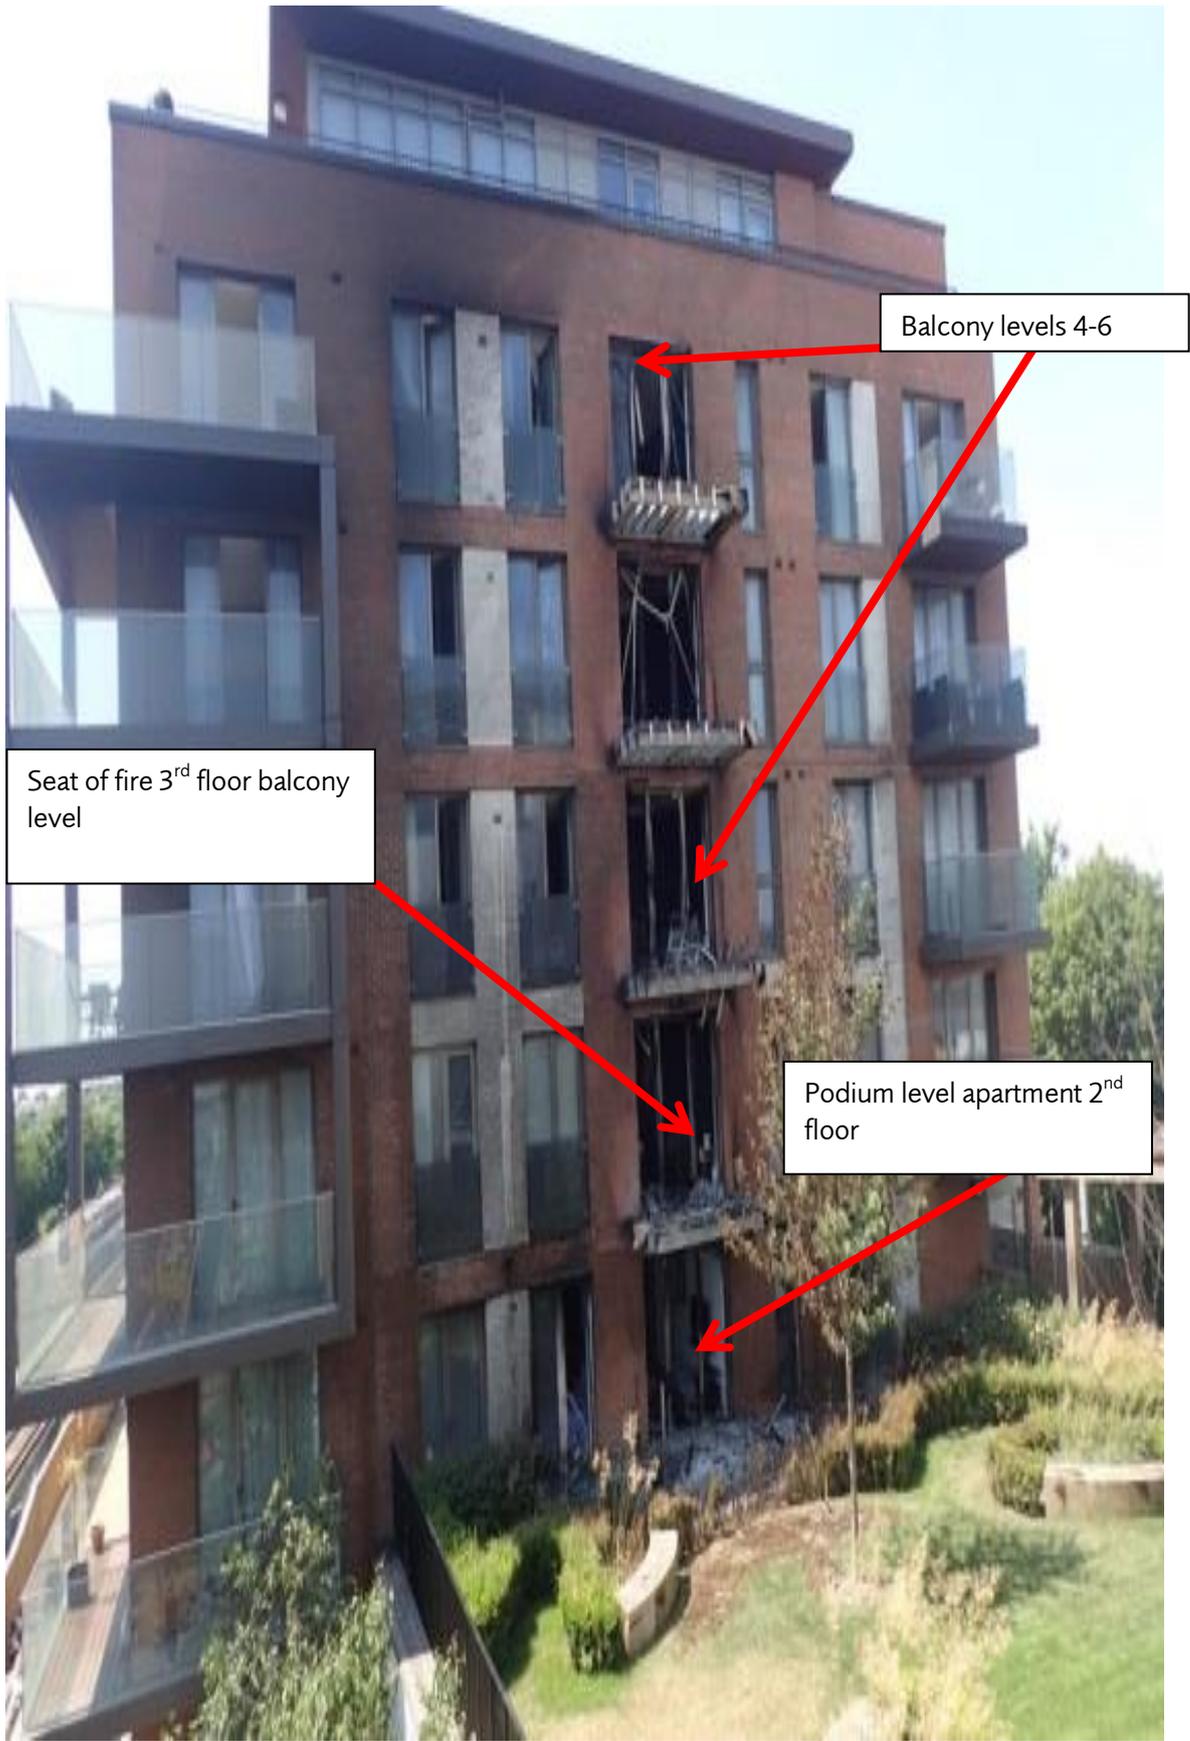
- 6.1 The fire started on the third floor external balcony, spreading vertically affecting three additional balconies from the fourth to sixth floor level. A further apartment located directly below the seat of the fire at second floor level (podium level) was also damaged by fire due to falling fire debris.

- 6.2 Fire and heat penetrated 5 apartments in total activating multiple nozzle heads ranging from 1 to 3 nozzle heads in each apartment, 12 in total. The cause of the fire has been recorded as careless disposal of smoking materials (cigarette butt) into a plant pot on the balcony of the third floor.

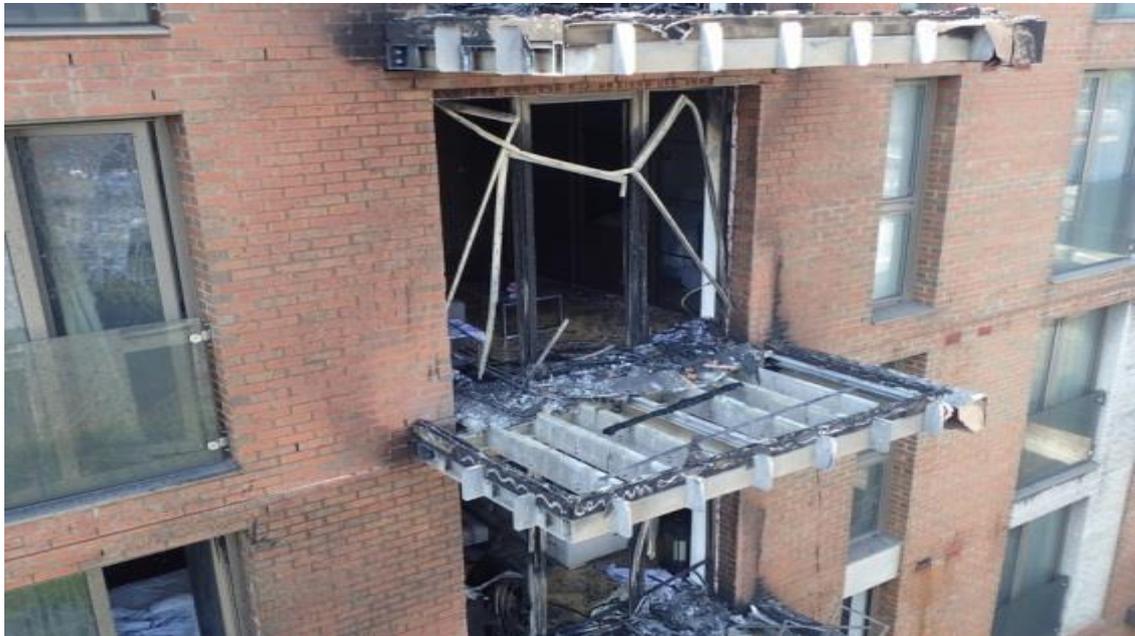
6.6 All four balconies' glazing units were completely destroyed by the fire with only the steel frame remaining, lateral fire spread did not occur and façade was of brickwork construction.

6.7 The windows located either side of the balconies sustained heat and smoke damage. The Podium level apartment sustained fire damage due to fire debris landing on the podium level adjacent to the apartment.

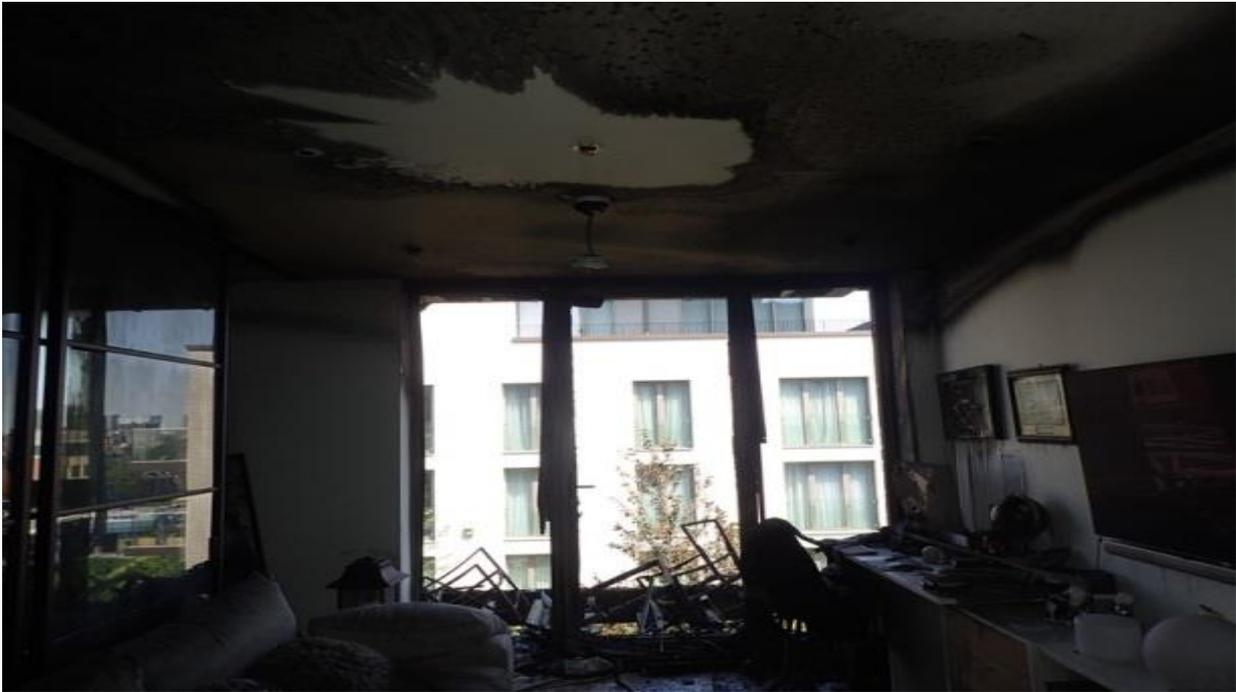
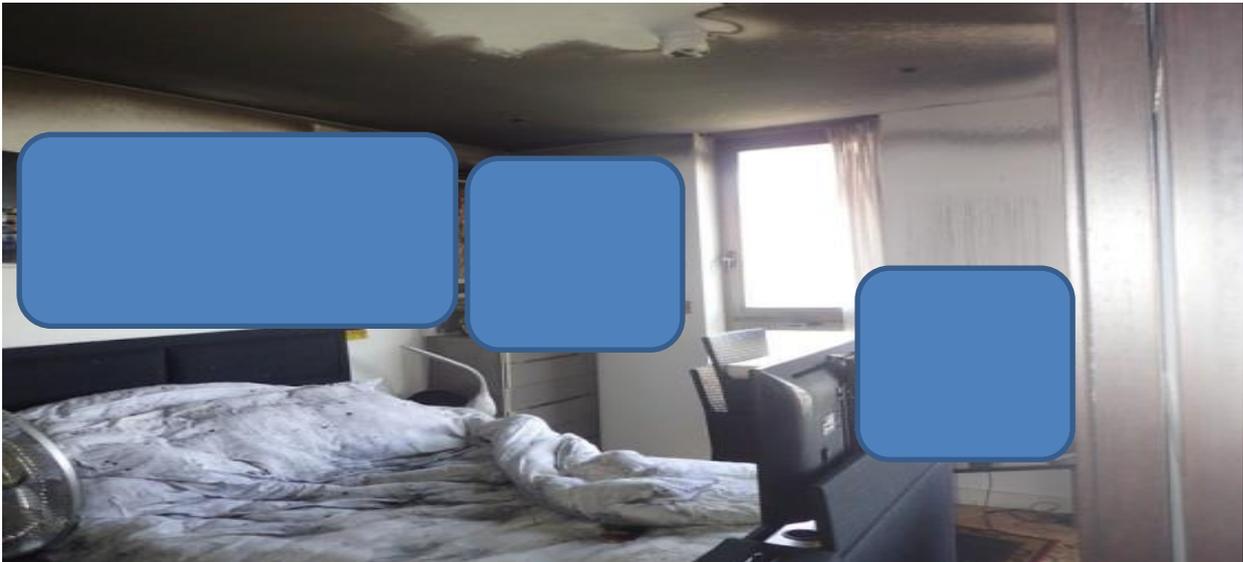
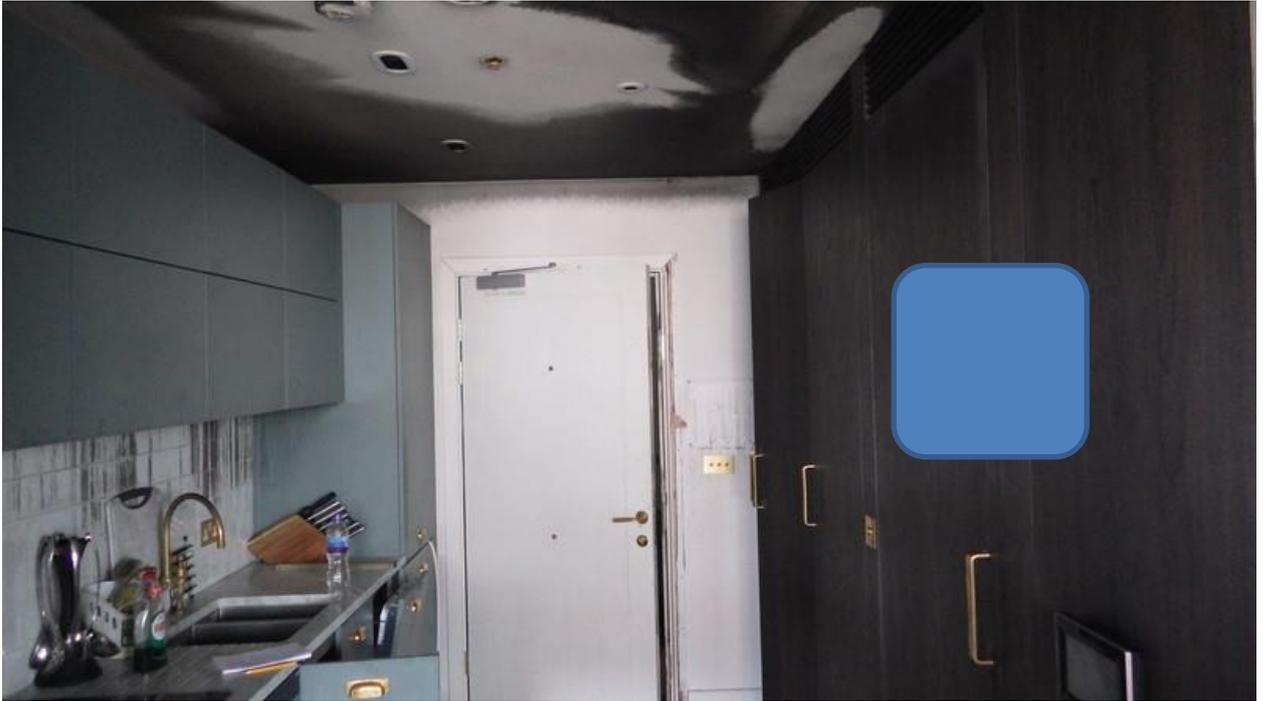
8.1 **11:32 4th Floor Level/Room 402 Suite/Studio Flat**, six minutes after time of call three nozzle heads actuated throughout the apartment.

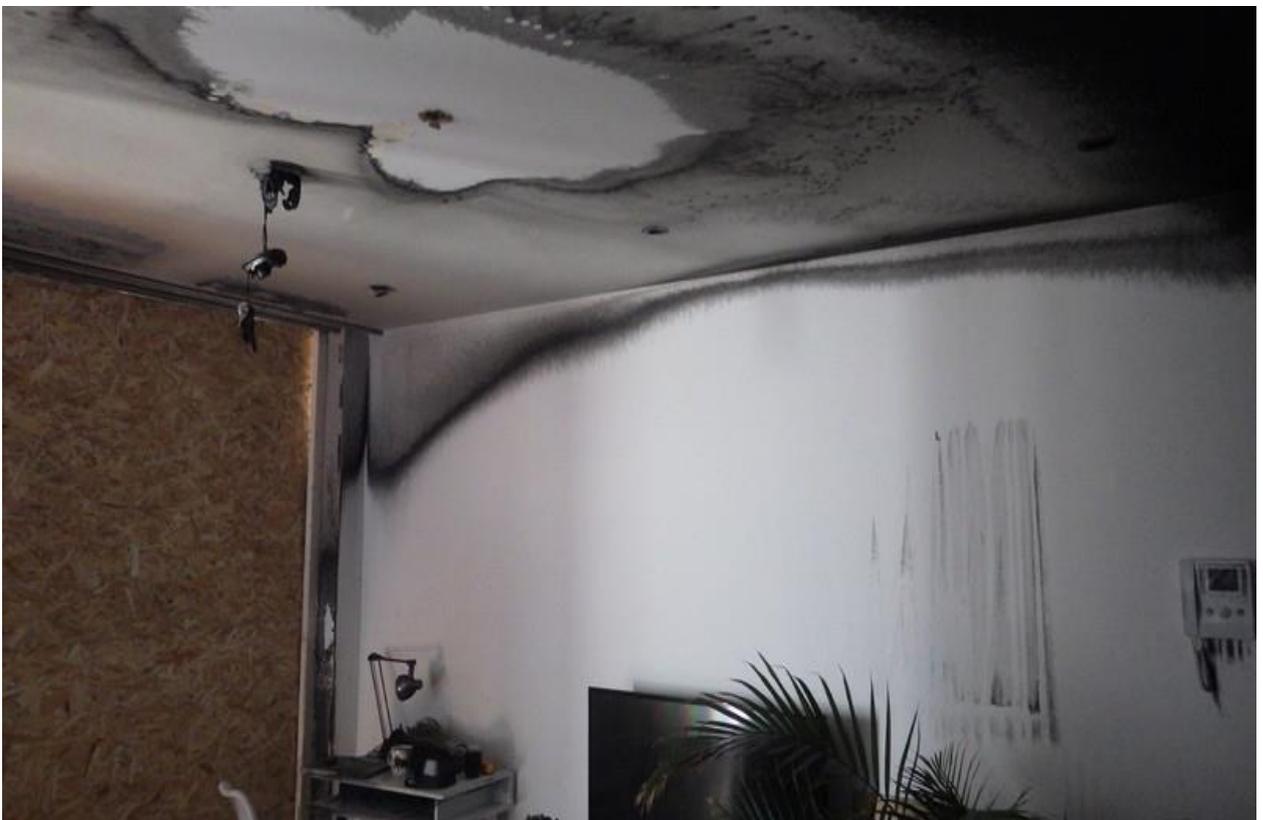
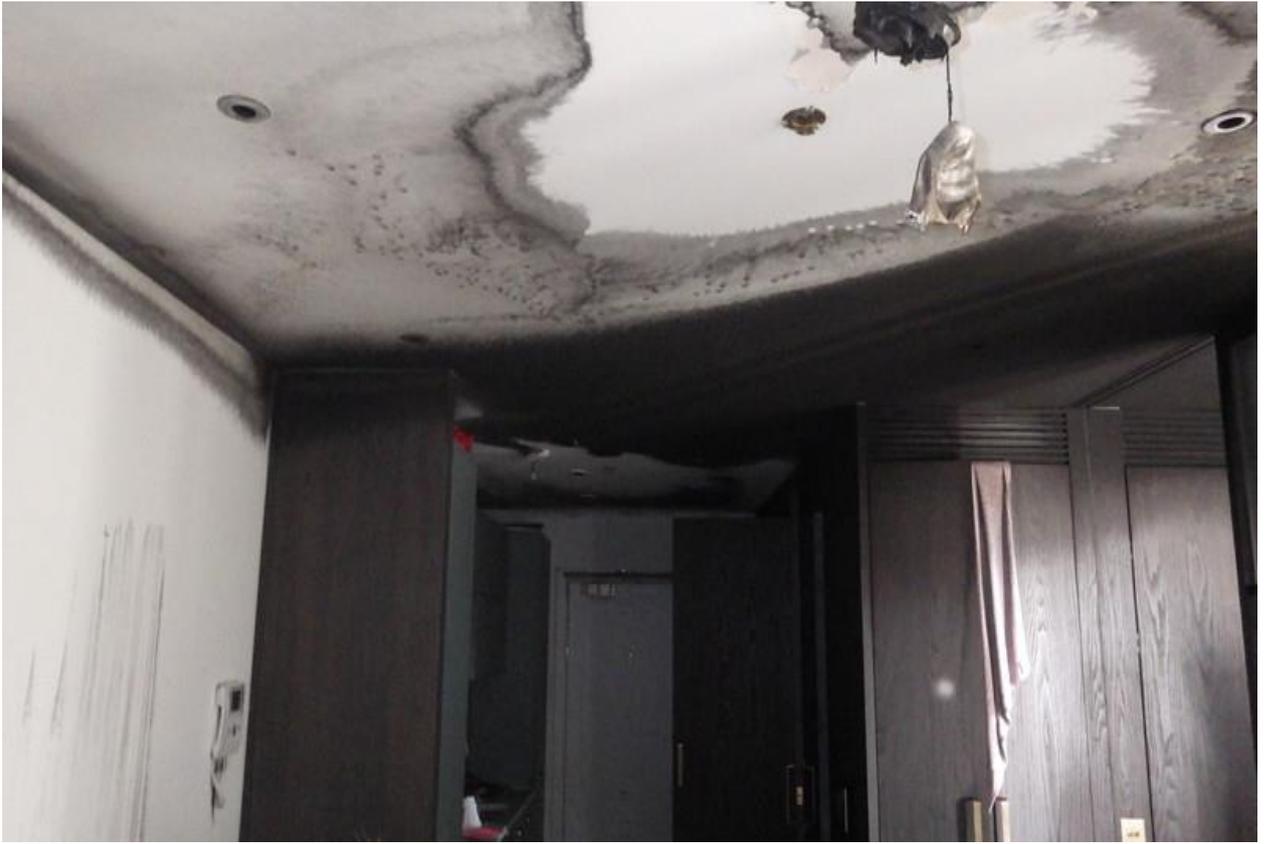
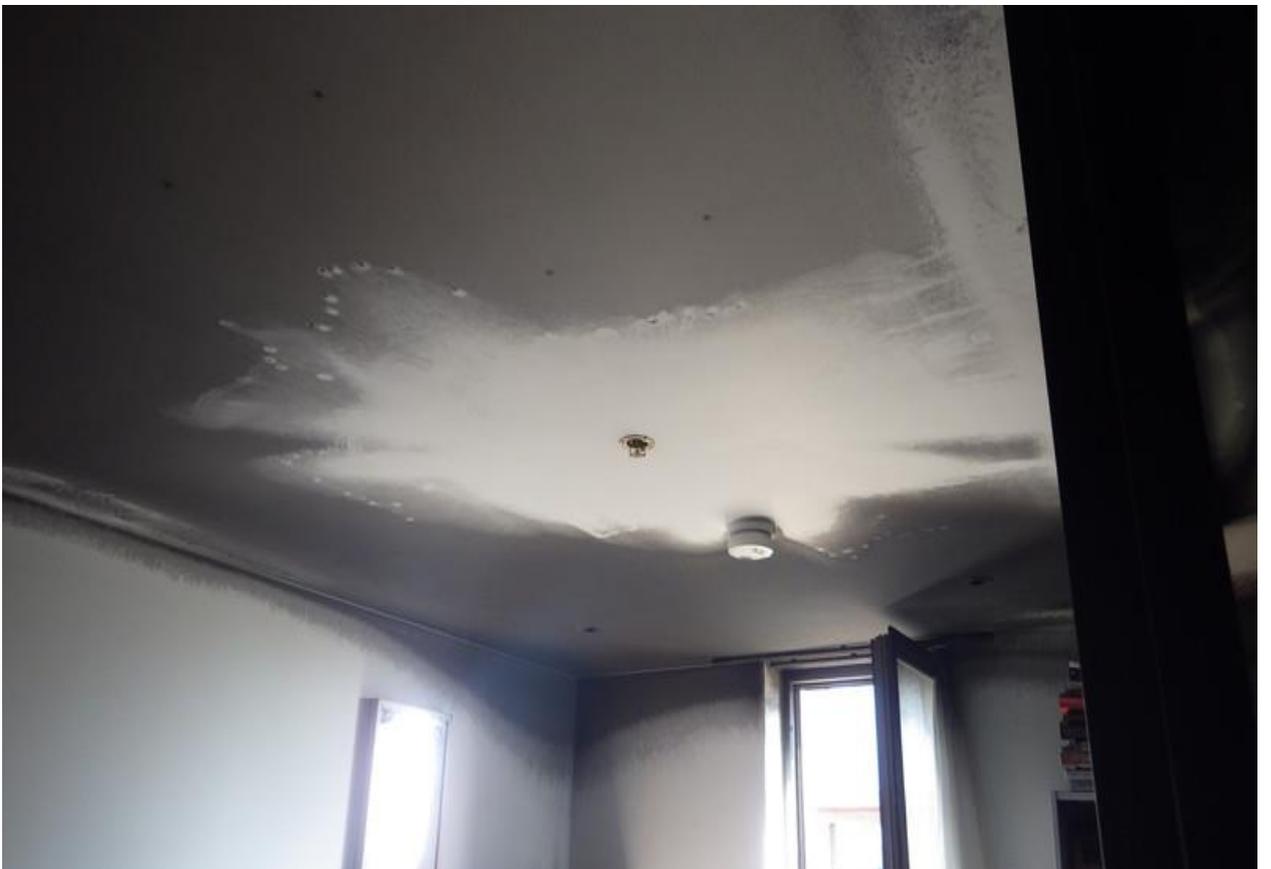
8.2 **11:32 3rd Floor Level/Room 302 Suite/Studio Flat**, six minutes after time of call three nozzle heads actuated throughout the apartment

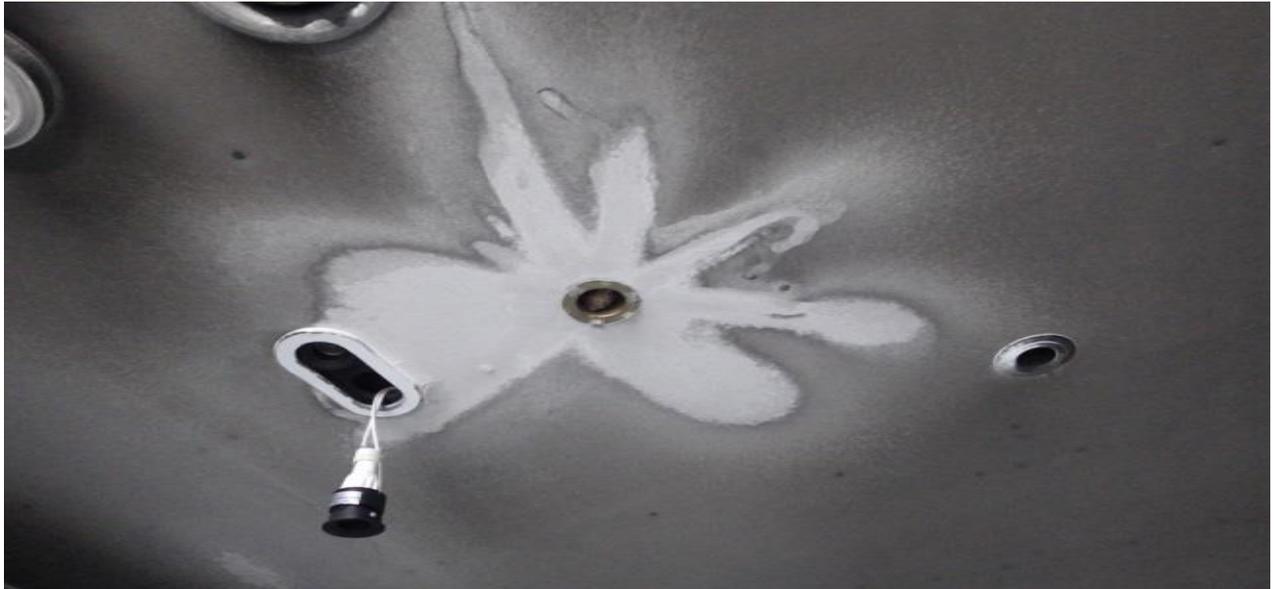
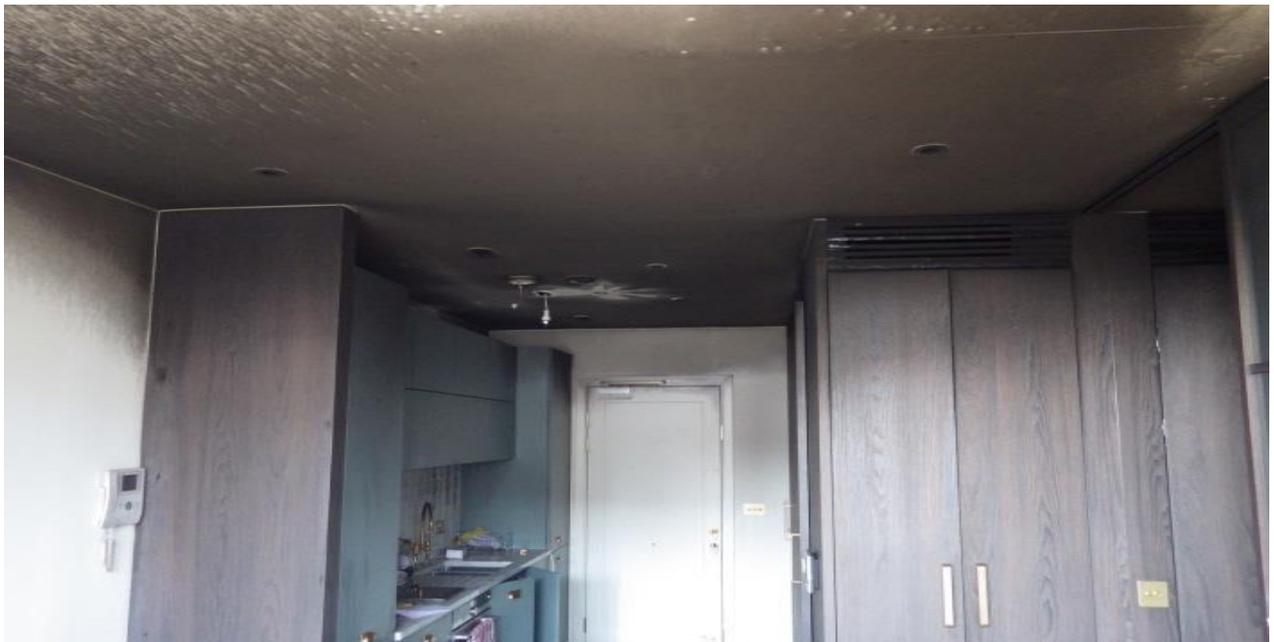
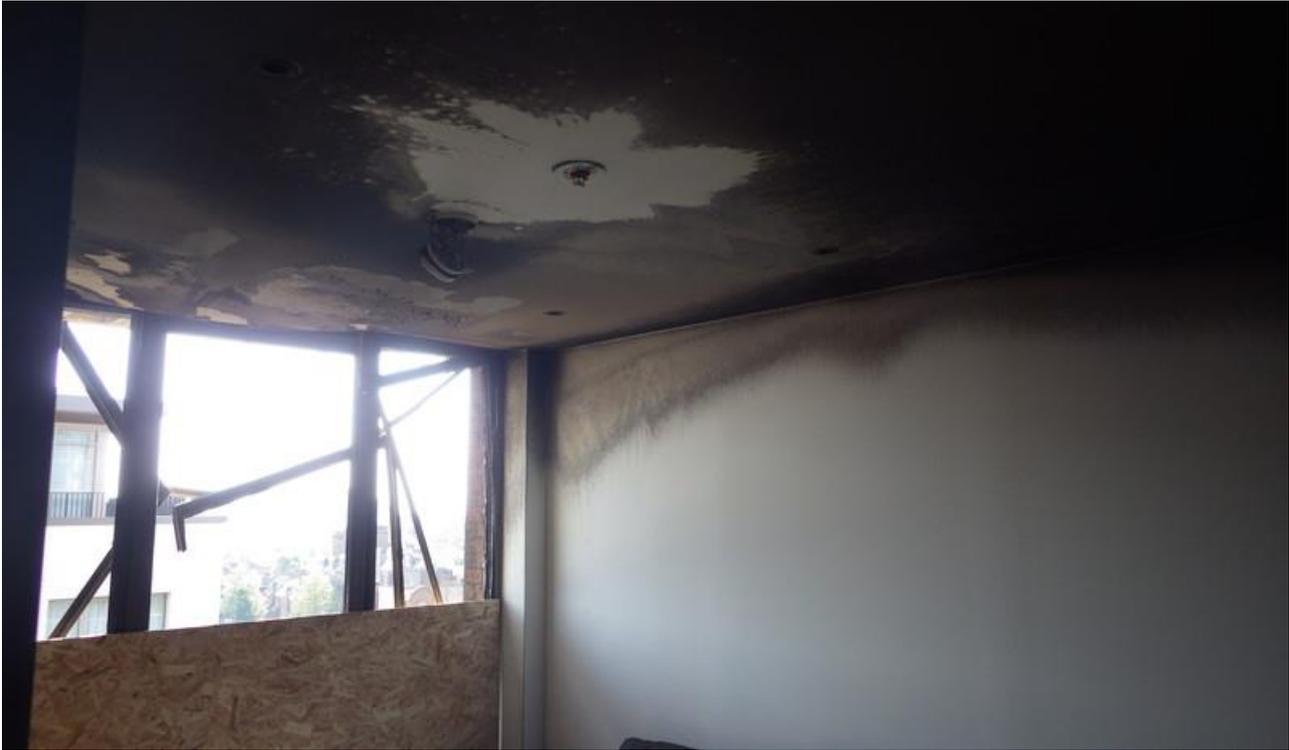
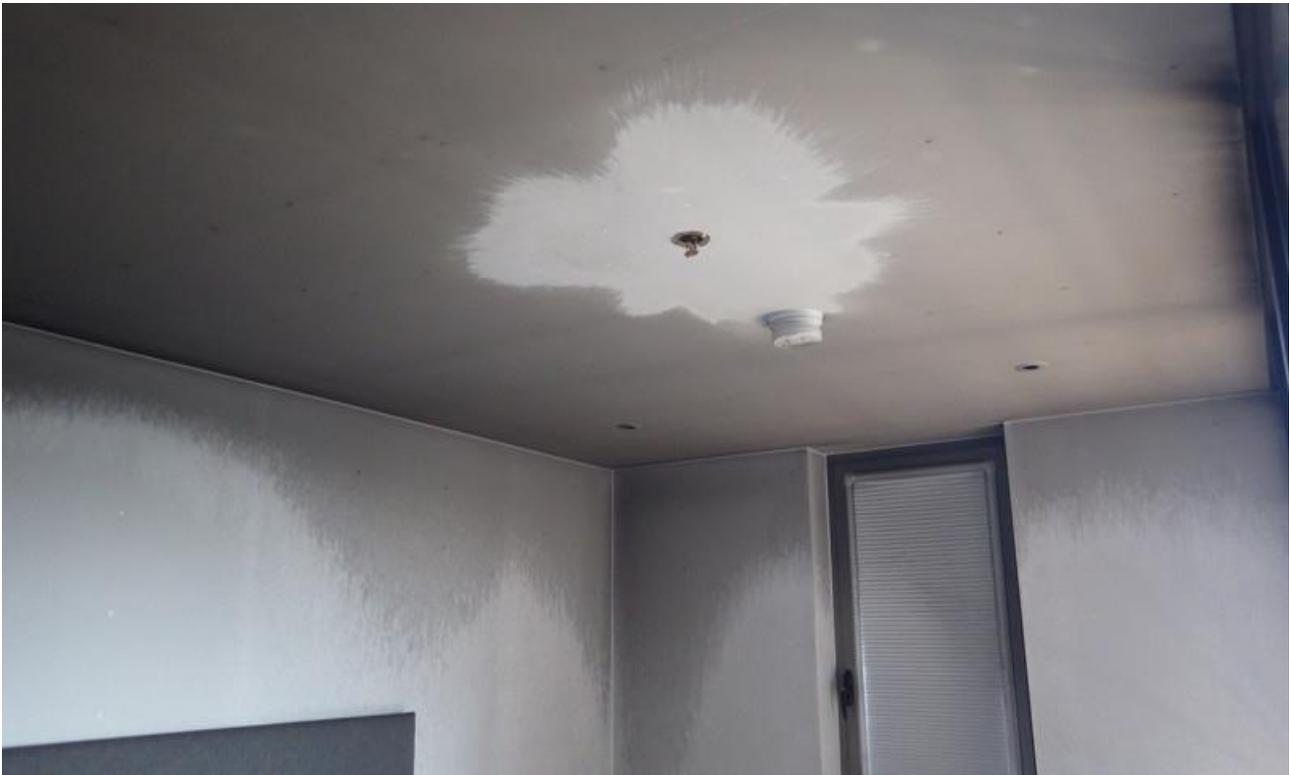
- 8.3 **11:34 :- 5th Floor level/Room 502 Suite/Studio Flat**, Eight minutes after the time of call, three nozzle heads actuated. The kitchen nozzle head spray coverage was found to have been compromised. It is not conclusive, one logical reason provided by the Residential Sprinkler Association was due to the fact that the nozzle head set was located too high in the ceiling void. If it had been installed another 5-10mm higher the front door and kitchen units would not have been wetted by the nozzle head.

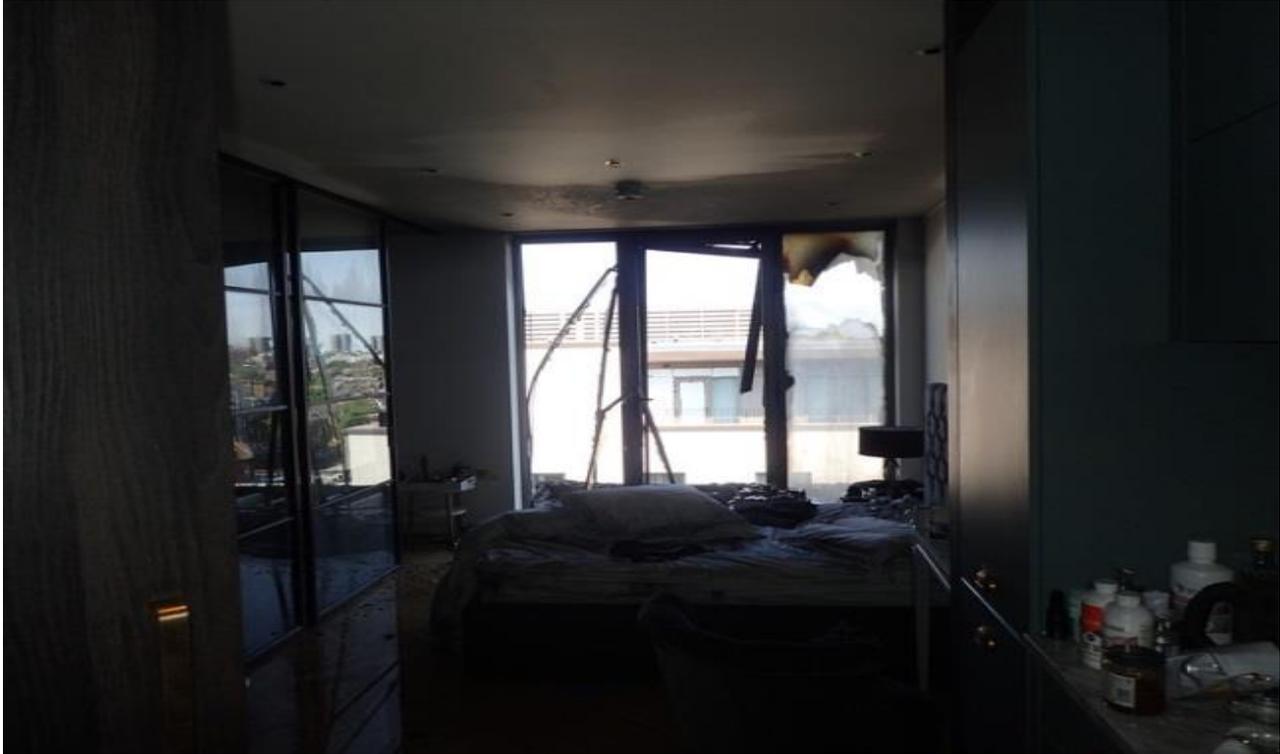
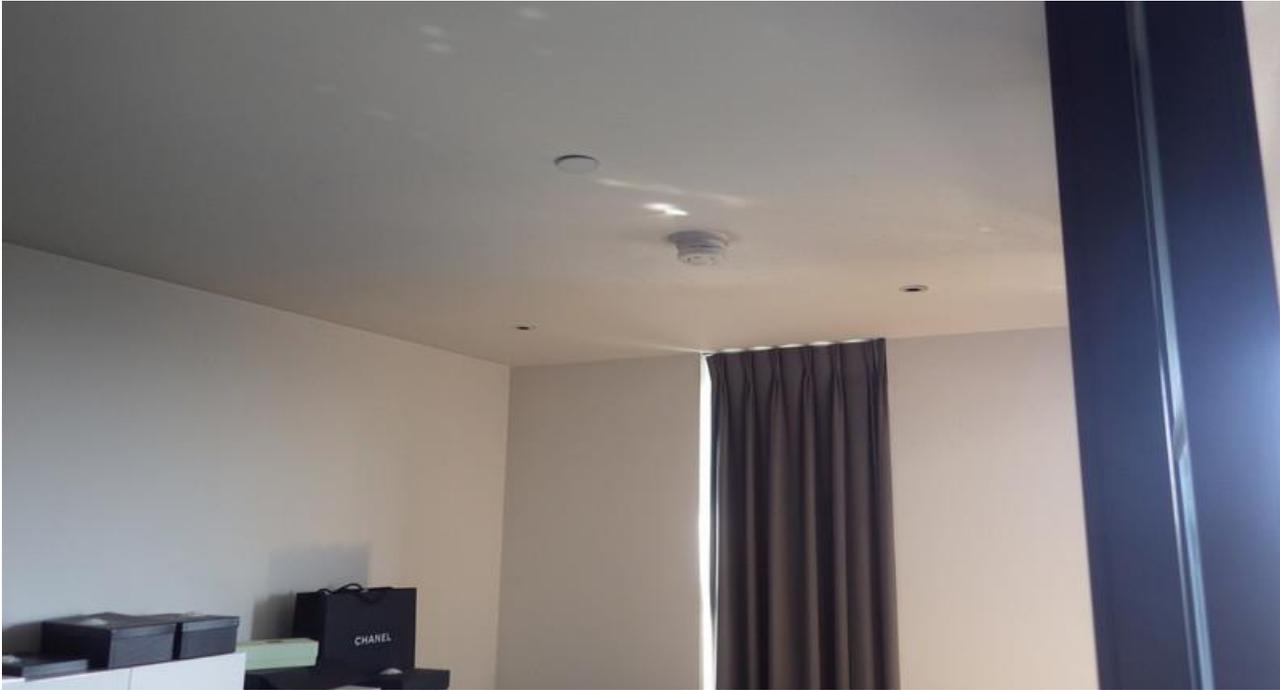
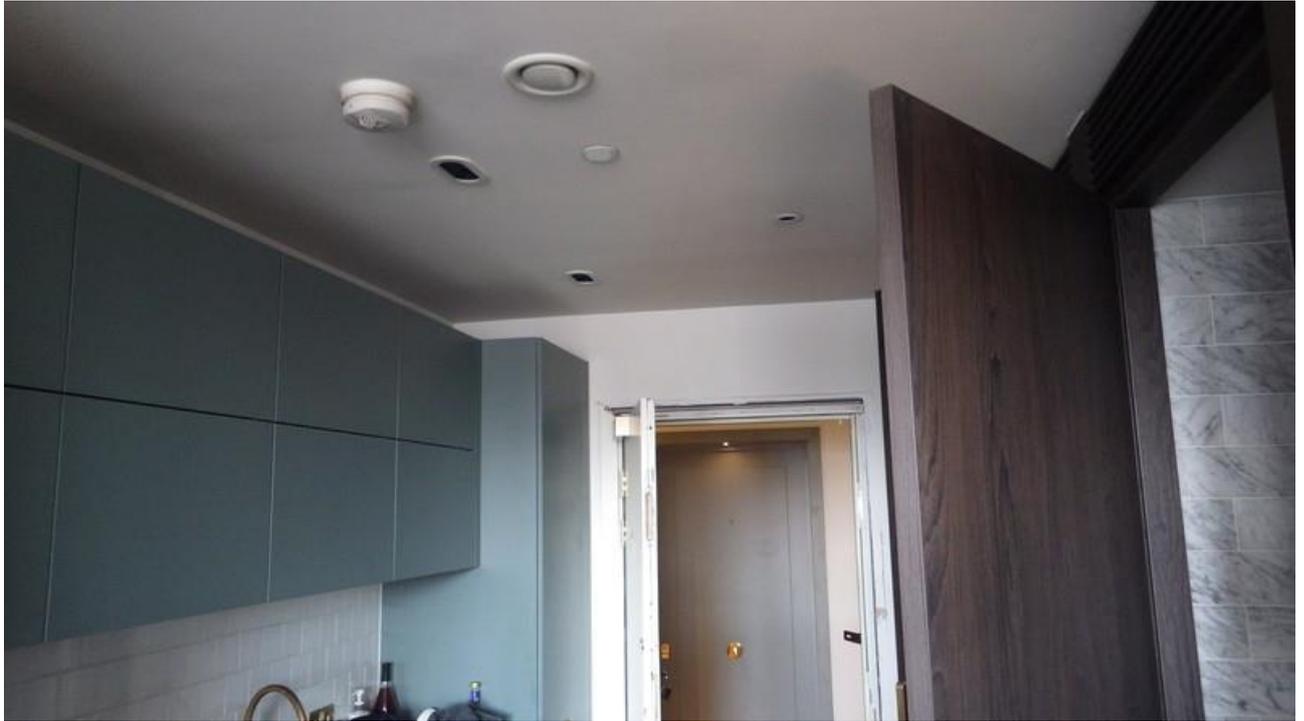
8.4 **11:38 :- 6th Floor level/Room 602 Suite/Studio Flat.** Twelve minutes following time of call, only one nozzle head operated in the living room area compared to the previous apartments where all three nozzle heads operated.

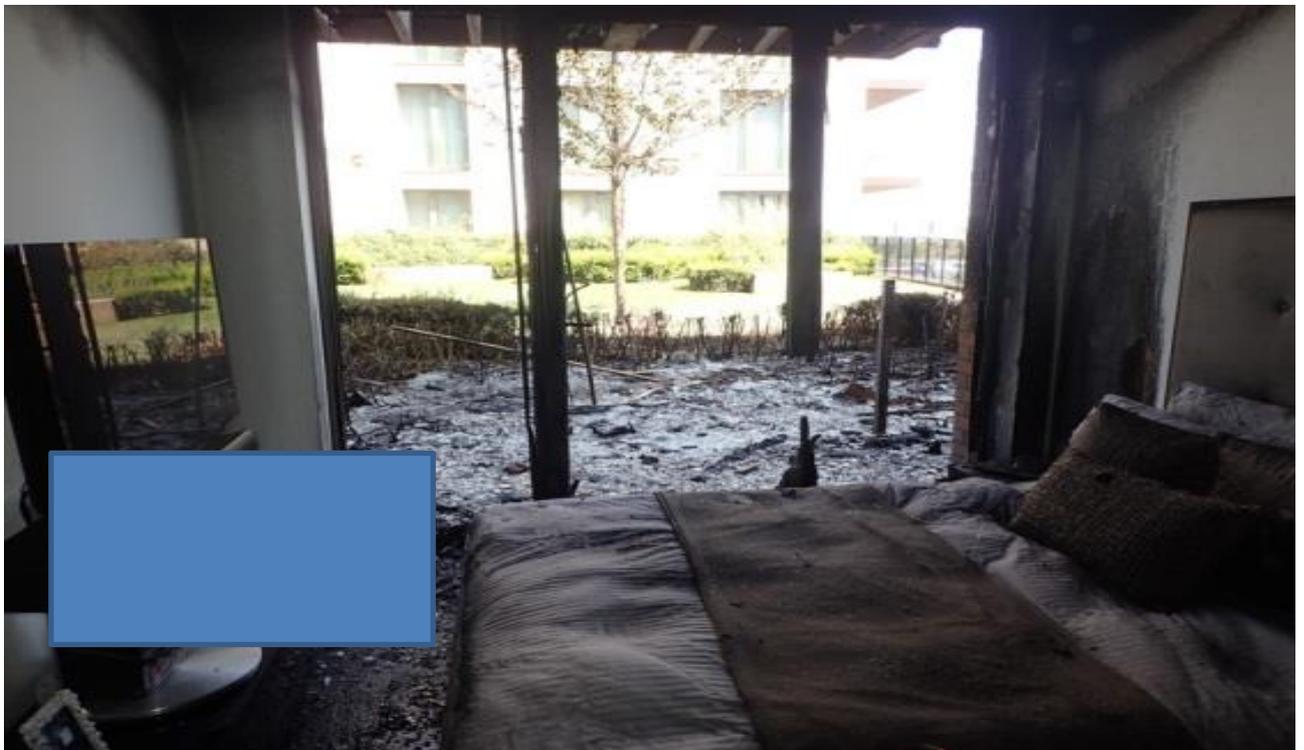
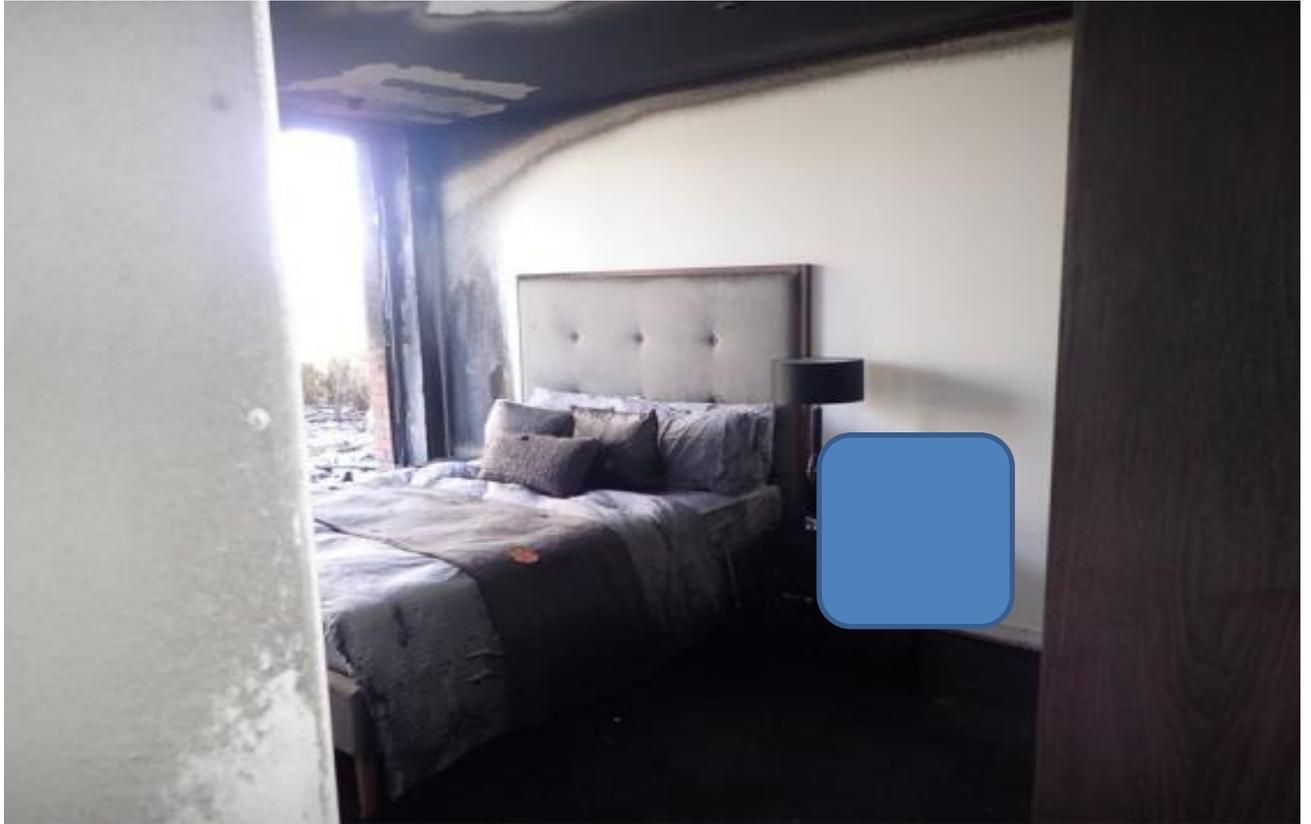
8.5 **11:51:- 2nd Floor level/Room 201, 2 bedroom flat**, Twenty five minutes after time of call 2 nozzle heads operated, 1 in each bedroom.

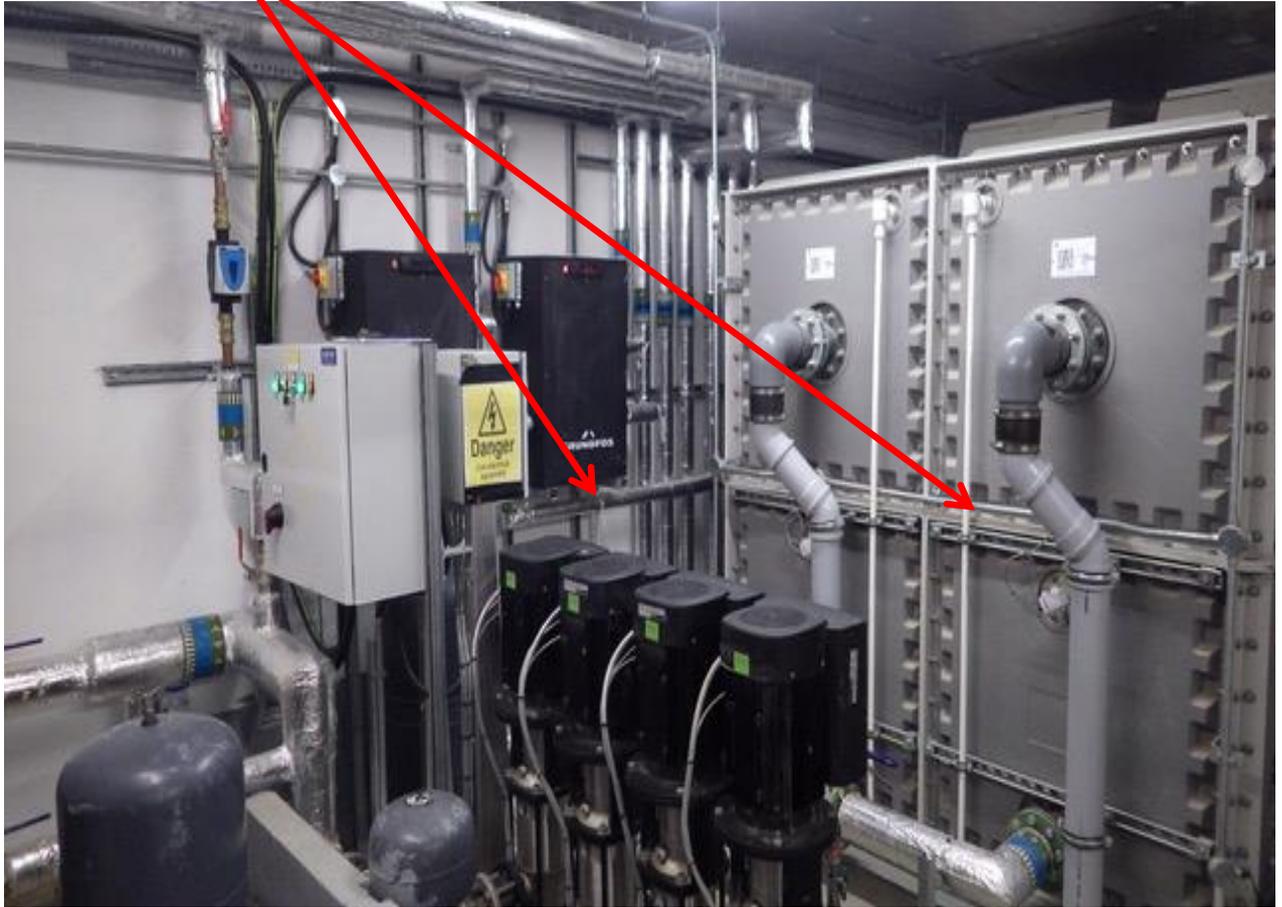
Capacity tank and pumps location, first floor plant room

- 11.1 Typically in a purpose built apartment block, a tank of water will be pumped to guarantee pressure and flow of cold water services to the flats as it was in this installation. This system can also be used for AFSS supplies however *special measures must be in place to safeguard sprinkler supplies and prioritise them in accordance with the above mentioned standard.

- 11.2 The effective stored volume must be able to provide the AFSS demand for the determined AFSS run time for the installation, with a minimum of 30 minutes duration. Residential x 4 heads operating for x 30mins (49 l/min x 4 x30 = 5880ltrs) provides for a worst case scenario not allowing for the infill, capacity of the tank was 6,300 litres.(60% of full holding is permitted with provable infill)

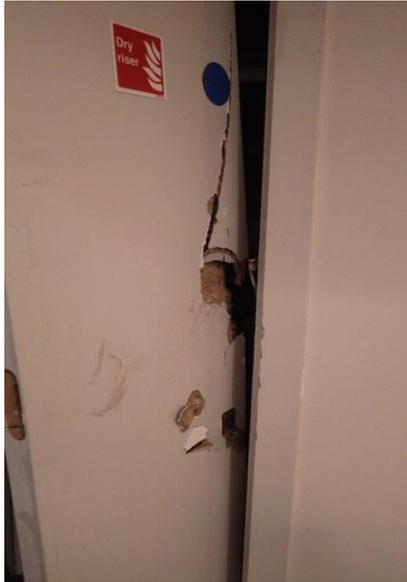
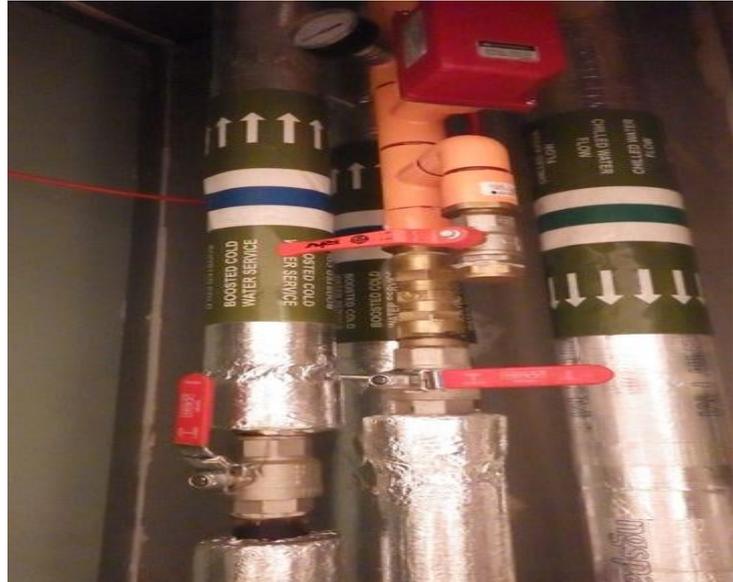
- No block/schematic plans identifying coverage of the AFSS, location of the AFSS tank room/floor isolation valves provided
- Signage not displayed on the riser cupboard doors housing the floor AFSS isolation valves
- No Premises Information Box

12.3 Considerable damage was sustained to a number of riser cupboard doors by crews trying to locate the landing isolation valves. Upon gaining access a number of isolation valves were visible, which one would you isolate?

12.2 Following the actuation of the AFSS, water damage can be an issue, particularly if insufficient information is available to allow operational crews to isolate the supply following the successful extinguishing of the fire which was the case with this incident.
