West Hampstead Square, Automatic Fire Suppression System Activation Case Study

Date of incident: Tuesday 3 July 2018

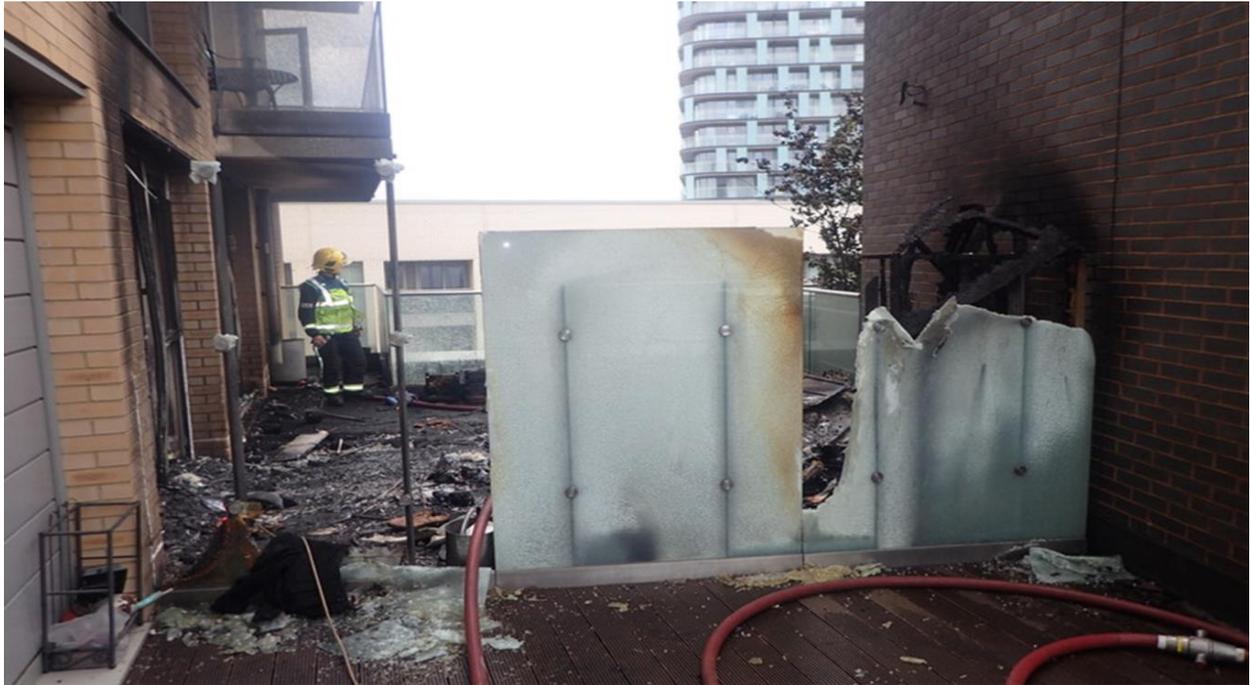
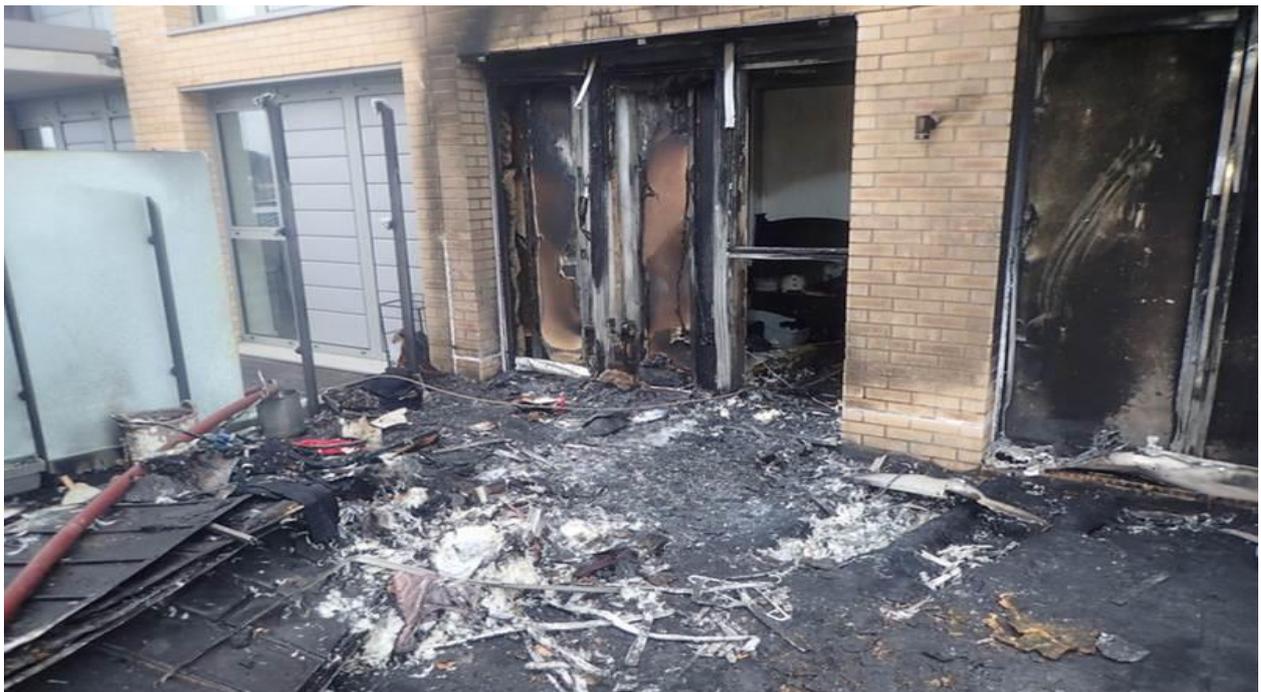
13.4 Previous incident, Elma Street, Lewisham.

- Purpose built residential block of flats.
- Date of Incident 20 June 2018.
- Residential apartment, 6 residential nozzle heads actuated suppressing the fire from spreading into the apartment.
