# **KINGS DOCK CAR PARK FIRE**

## **PROTECTION REPORT**

*April 2018*

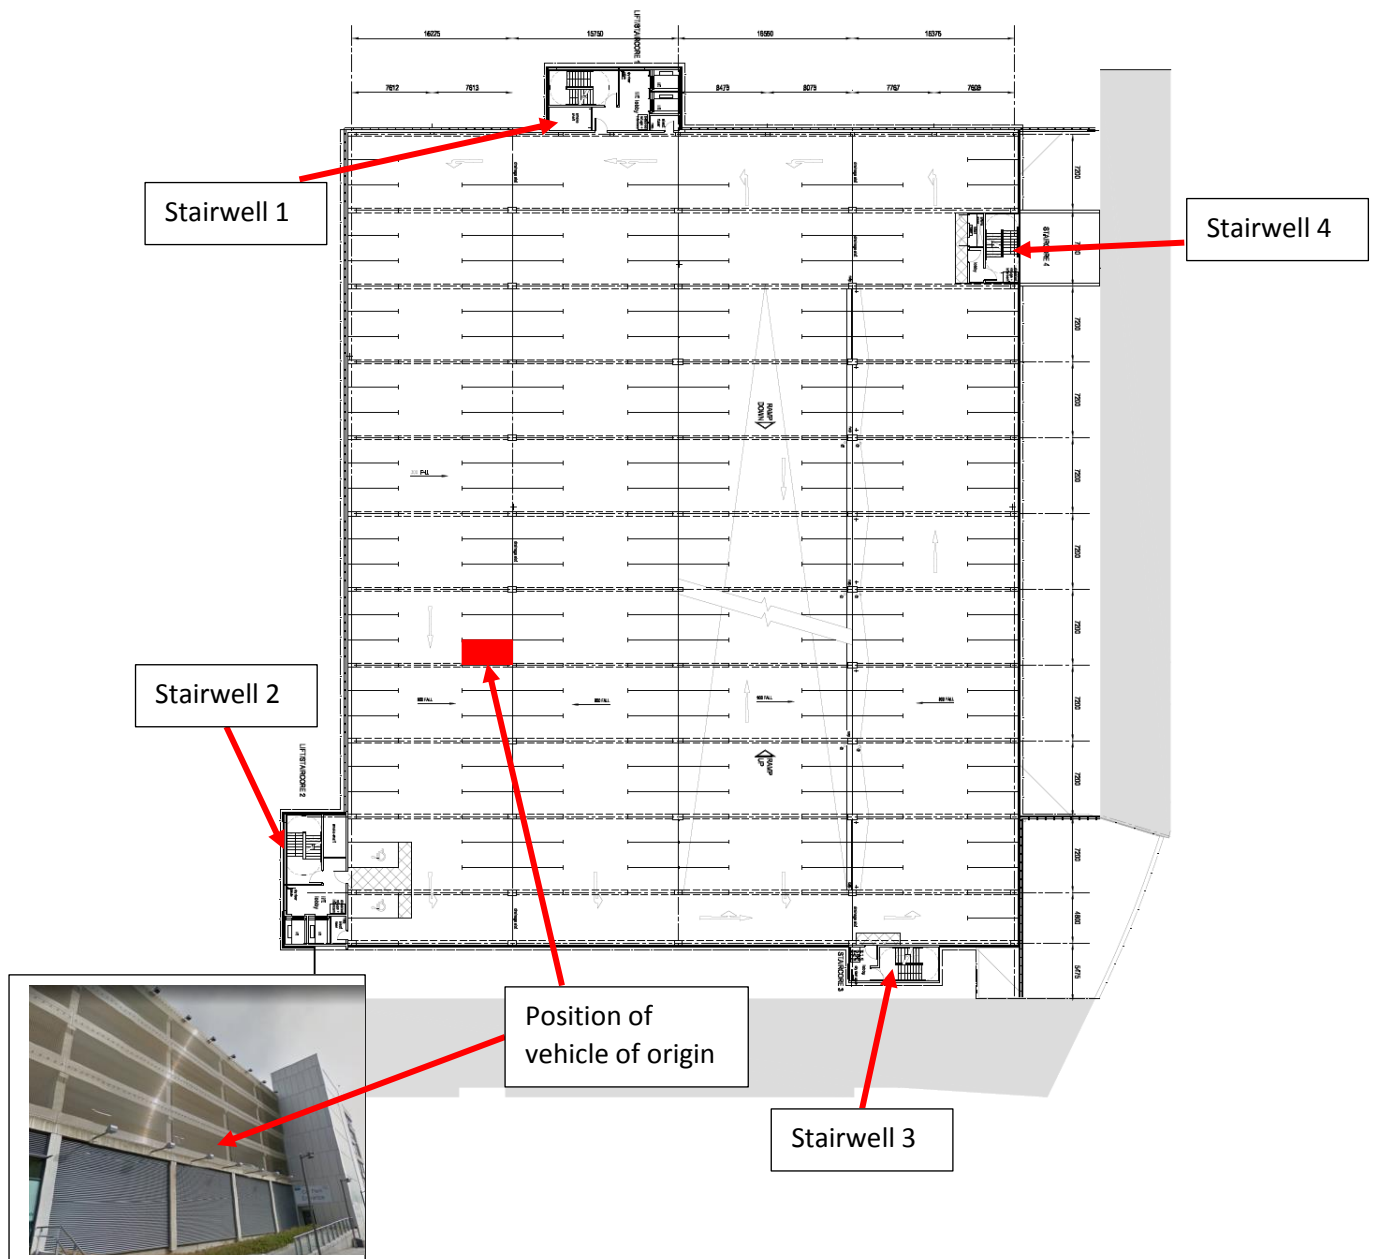
Figure 0.2: Level 3 floor plan

MF&RS were alerted to a car on fire on the 3<sup>rd</sup> floor of the Kings Dock Car Park at 16:42hrs, New Year's Eve, Sunday 31<sup>st</sup> December 2017. The resulting blaze led to the loss of approximately 1,150 vehicles and so severely affected the fabric of the building that demolition is the likely outcome. A visiting contingent from the Building Research Establishment (BRE) on 10<sup>th</sup> January 2018 likened the fire to a petrochemical fire; due to the heat generated and the behaviour of the concrete structure (evidence of explosive spalling, floor failure and structural element damage).

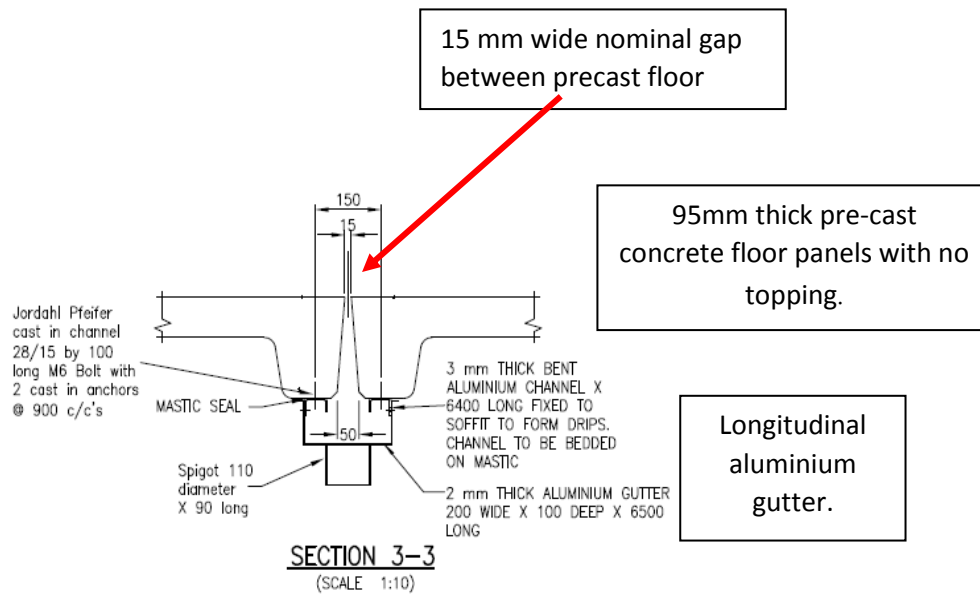
Figure 2.2.3: Extract from Level 2 Structural GA drawing 04248/15

This drainage slot runs between columns with two rows of three cars parked between each column (see fig.2.1).

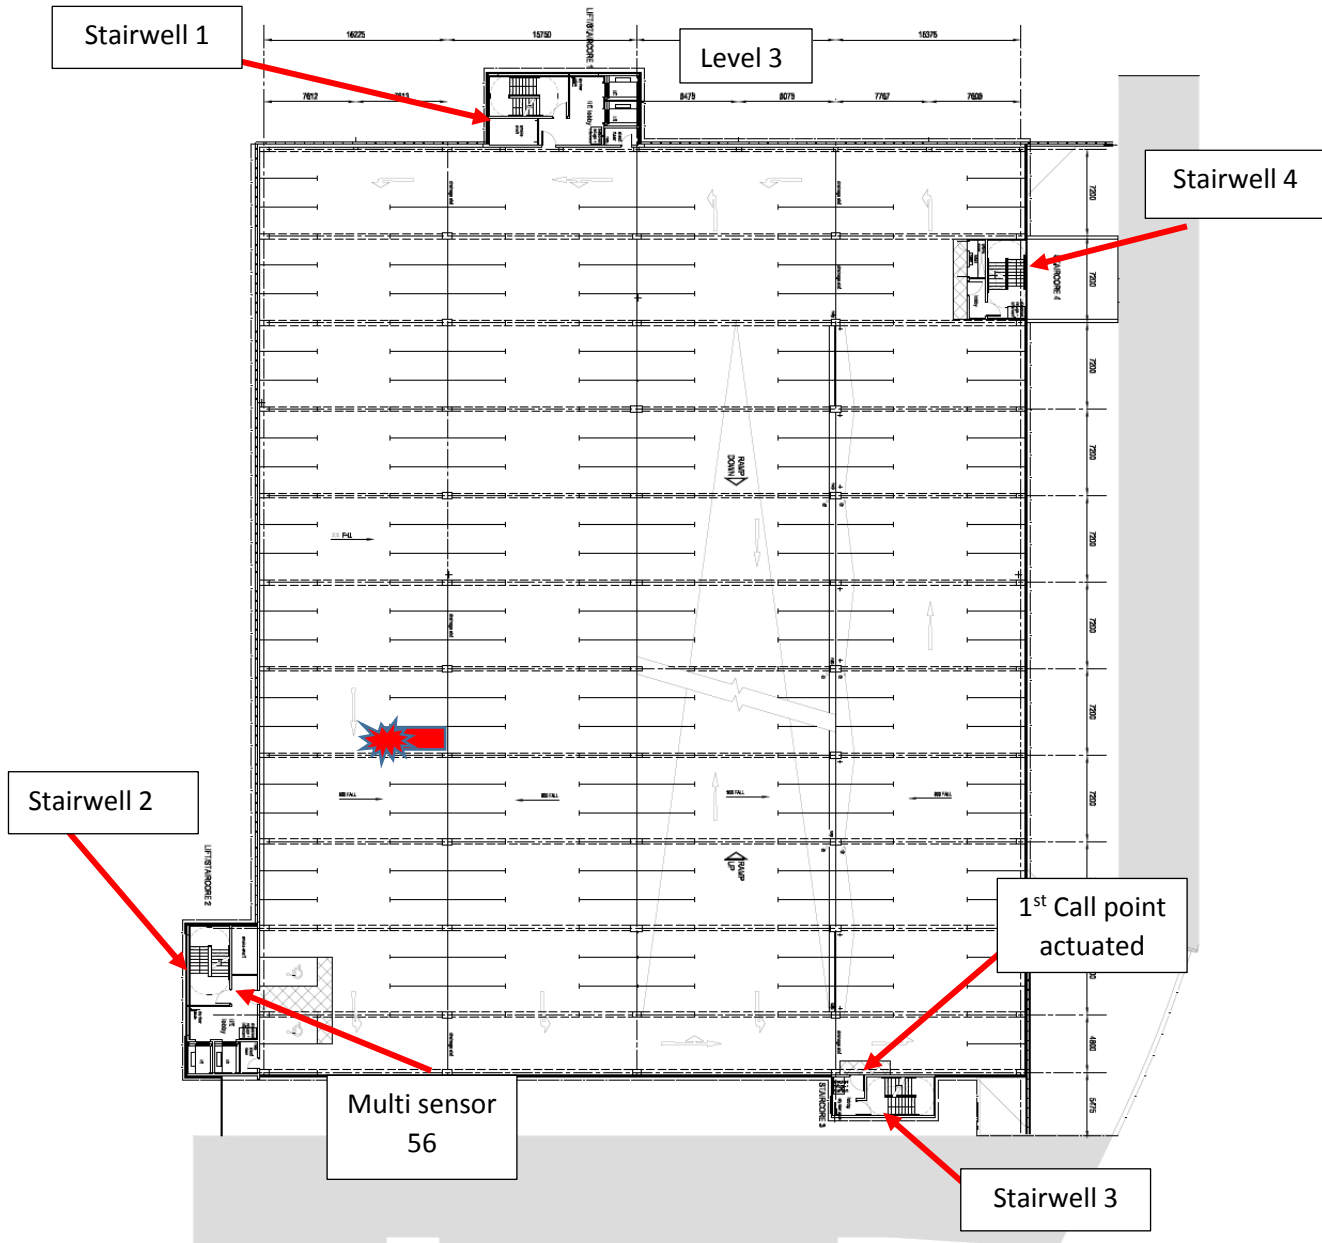
Figure 3.4.1: Level 3 floor plan

The car park is served by a combination of a manual and an automatic fire alarm system, complying with BS5839-1. There are manual call points on all levels of the car park, adjacent to protected stairwell exits.

The fire alarm was first actuated at 16:43:49, alarm panel indicating call point 64, level 3, adjacent to escape stairwell 3.

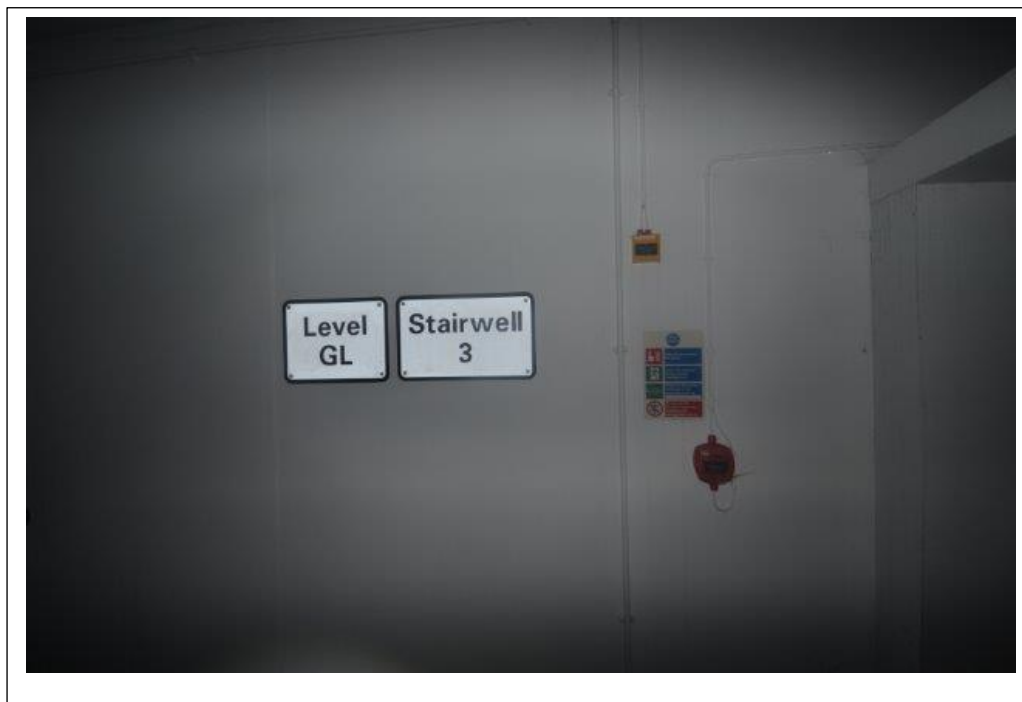
**Figure 3.4.6 Active Protection Measures, ground floor, Stairwell 3**

The protected stairwells have dry risers, automatic openable vents with manual overrides, automatic detection on all levels refuge points with communications and manual call points are sited adjacent to final exits.

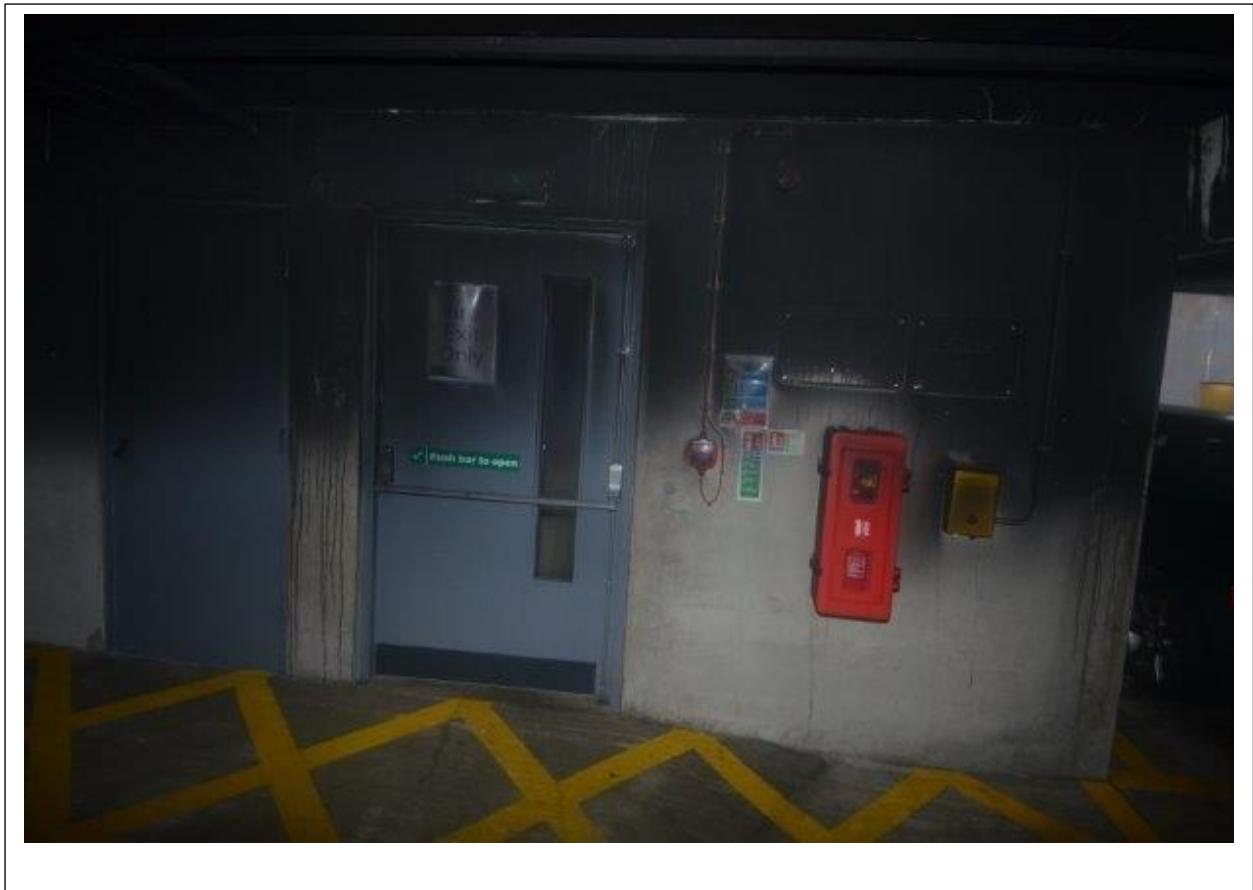
**Figure 3.4.7 Fire point and exit, Level 1 Stairwell 4**

Fire extinguishers are located adjacent to call points on all levels and additional firefighting equipment and a fire event team were provided by WH Management during the event. The remit of the event firefighting team within the car park did not extend beyond the stabled area on the ground floor.

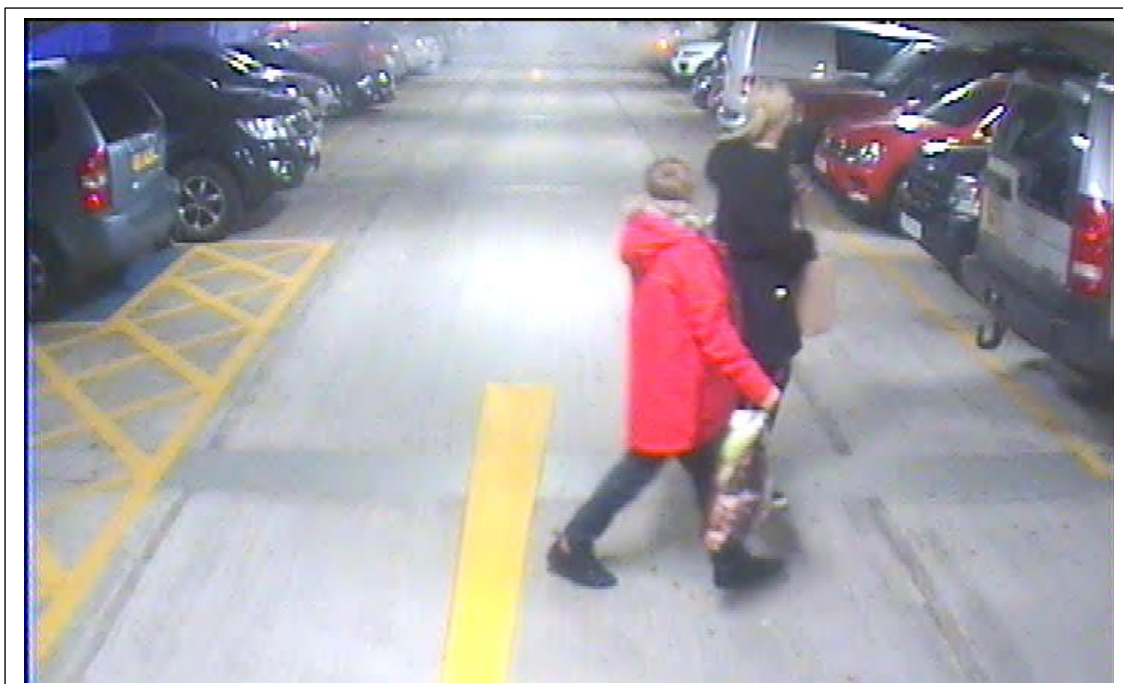
**Figure 5.1.1: CCTV still frame**

The CCTV images below (**Figure 5.1.1**) was taken just before first 999 call. None of these witnesses called 999 or raised the alarm and the image overleaf (**Figure 5.1.2**) captures the event approximately 3 minutes prior to 999 call.

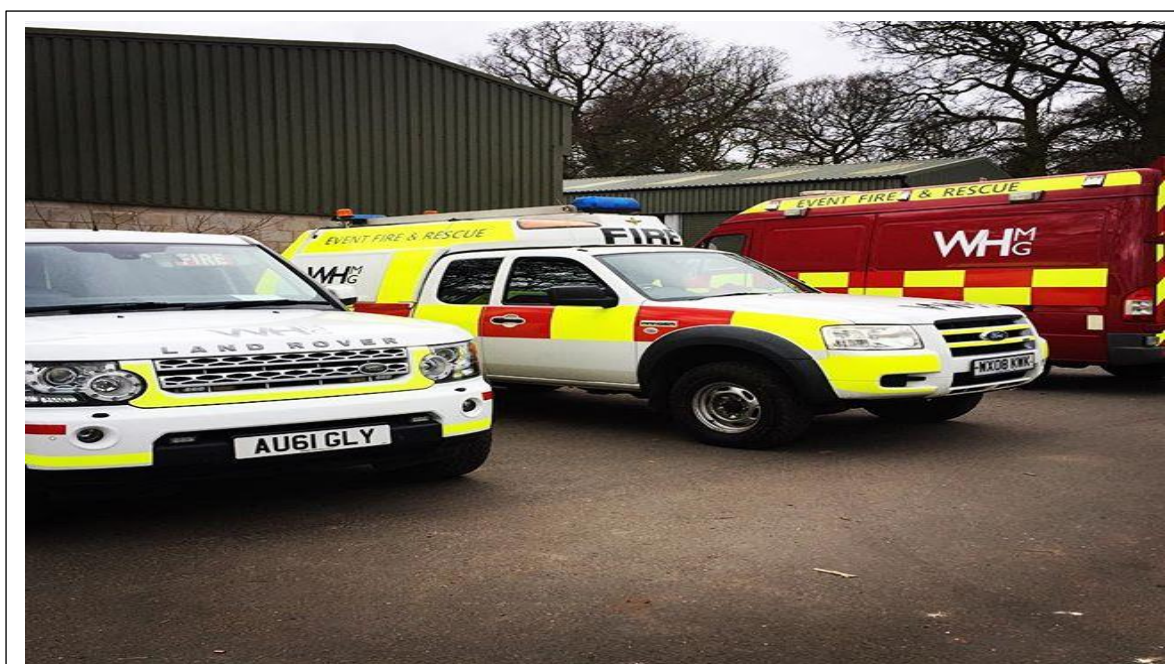
**Figure 5.1.3: WH Management Emergency Response vehicles**

An “Event Firefighting Team” was in attendance by 16:45hrs. They parked outside the main entrance to the car park, in a vehicle which had blue flashing lights and “fire & rescue” livery. This may have led members of the public to believe that MF&RS were in attendance and reduced number of 999 calls.
